Expertise

Protocol number: 48508022
Order No. / Reference: 27211739
Inspection date: 3 Nov 2026

Manufacturer: Peugeot	Model: 508 SW Plug-In Hybrid 225 e-EAT8 GT
VIN: VR3F4DGZTNY654906

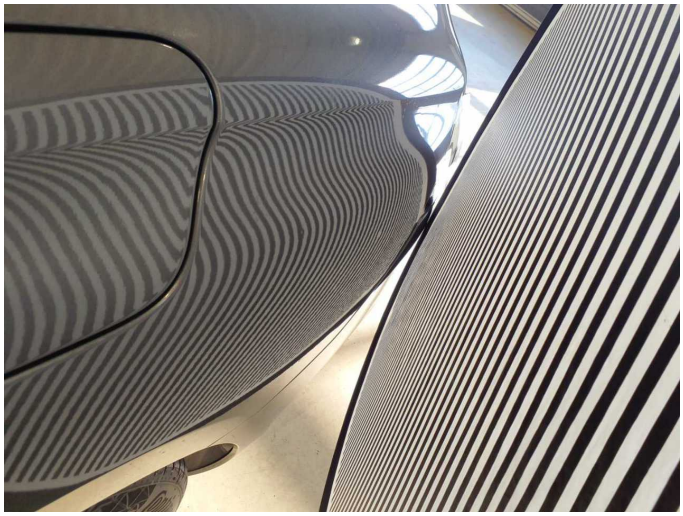
Damage 5: Side panel - rear left side: Side panel - dent(s) - Smart repair

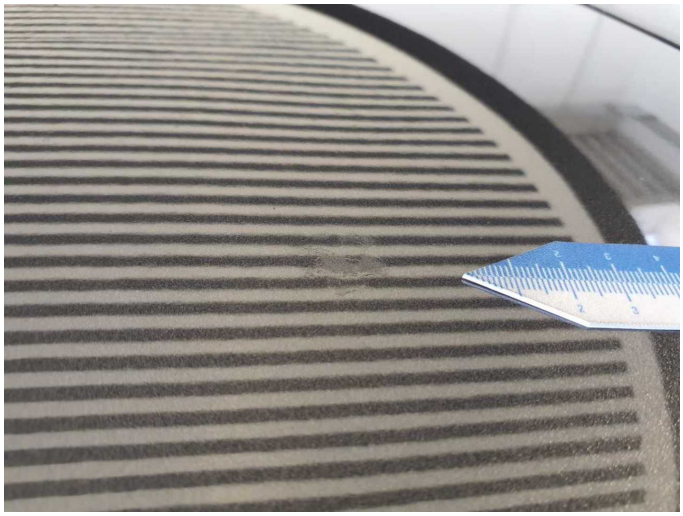
Damage 12: Roof: Roof (Anätzung) - Paint defect - Lacquer

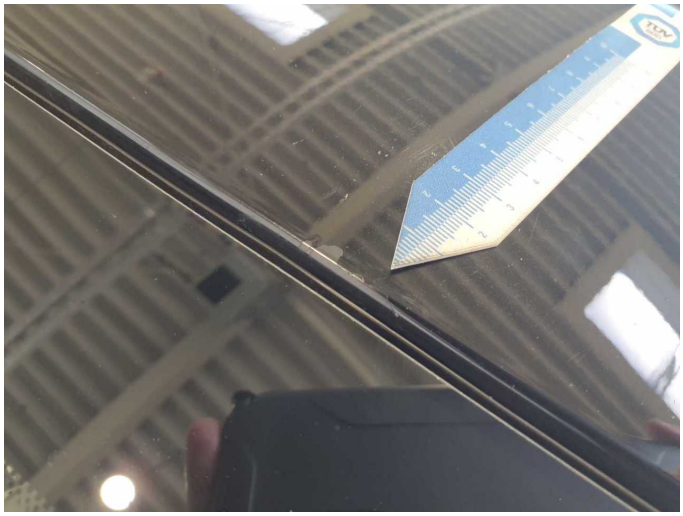
Damage 12: Roof: Roof (Anätzung) - Paint defect - Lacquer

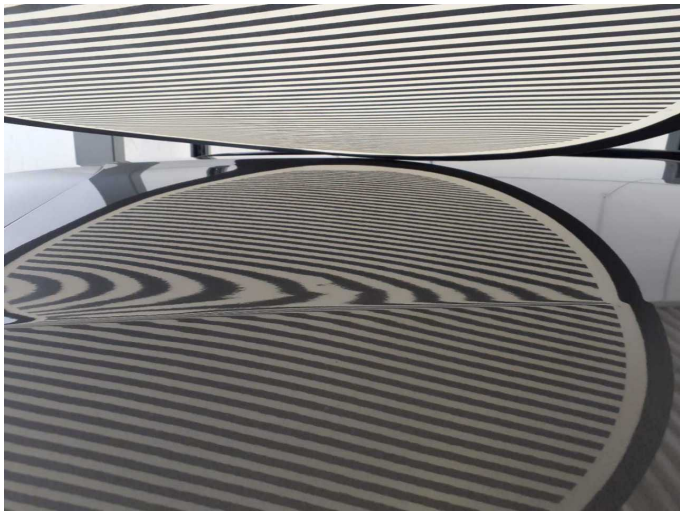
Damage 12: Roof: Roof (Anätzung) - Paint defect - Lacquer
