Expertise

Protocol number: 48415484
Order No. / Reference: 27025381
Inspection date: 30 Oct 2026

Manufacturer: Seat	Model: Tarraco 2.0 TDI SCR DSG Xperience
VIN: VSSZZZKN9RW002297

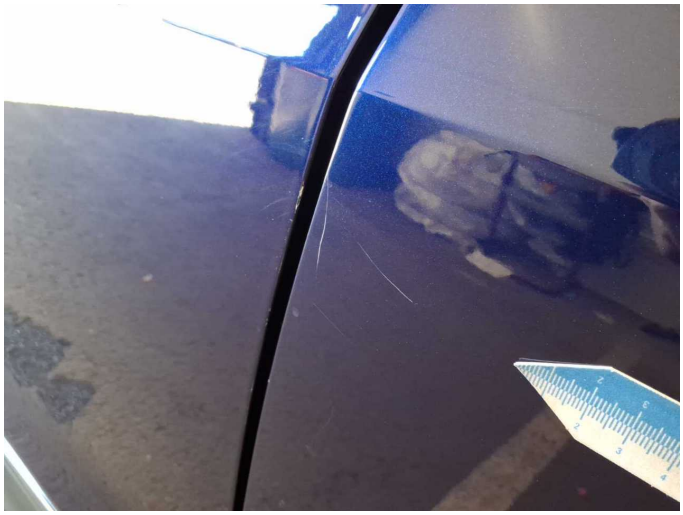
Damage 4: Door - rear left side: Door - Scratch(es) - Paint

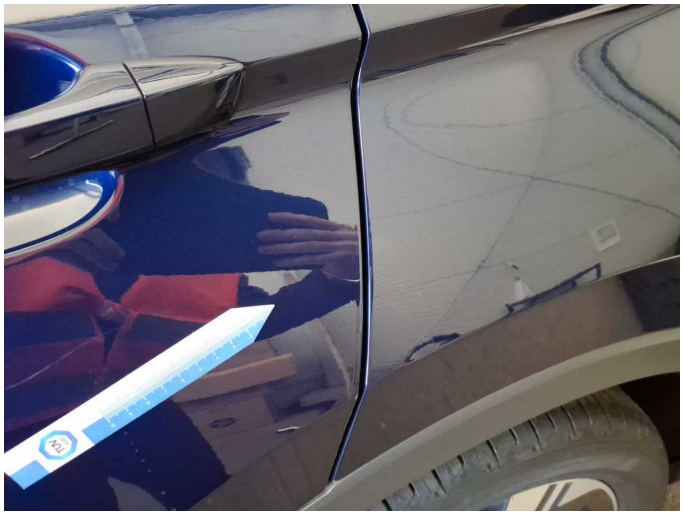
Damage 4: Door - rear left side: Door - Scratch(es) - Paint
