Expertise

Protocol number: 48008929
Order No. / Reference: 26959422
Inspection date: 16 Sept 2026

Manufacturer: Mercedes-Benz	Model: GLC-Coupe 200 d 4Matic 9G-TRONIC
VIN: W1N2533161G114900

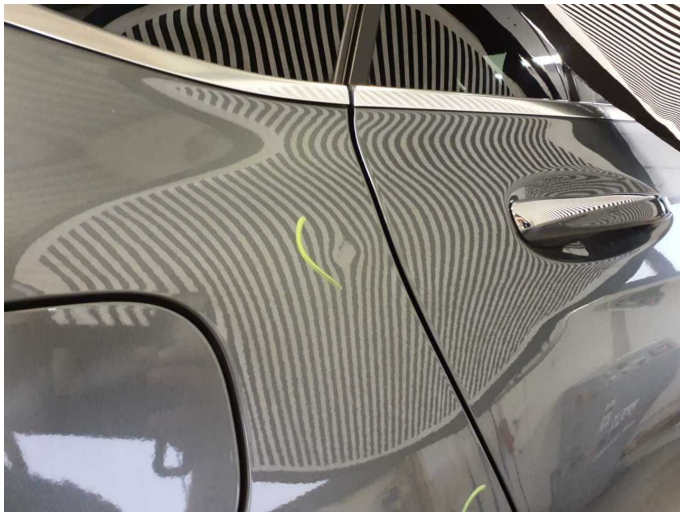
No.	Component group	Description
1	Trim / covers	Door trim - front left side - Damaged - Smart repair
2	Side panel - rear right side	Side panel (3 Dellen) - dent(s) - Smooth repair work
3	Front bumper	Front bumper - Malposition - Set / adjust
4	Rear bumper	Rear bumper (unpainted) (im Verbund Stoßfänger lackieren) - Scratched - Replace
5	Rear bumper	Rear bumper - Scratch(es) - Paint

Damage 2: Side panel - rear right side: Side panel (3 Dellen) - dent(s) - Smooth repair work

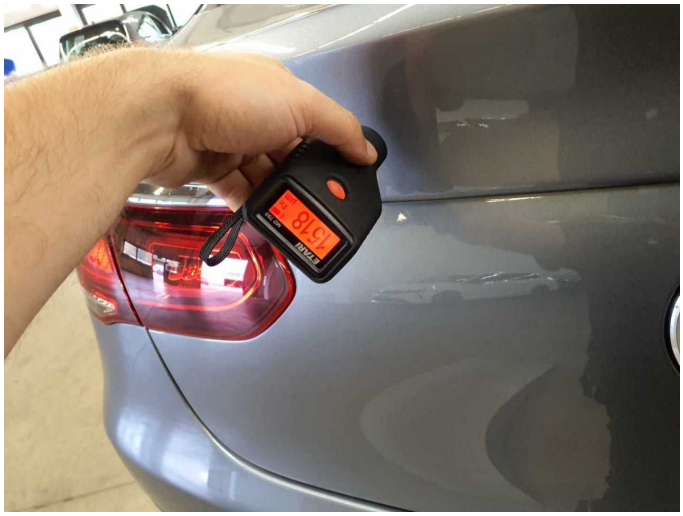
No.	Repainting
1	Boot lid / rear door, Professionally carried out, Invoice of repair done Non-existent

Repainting 1: Boot lid / rear door

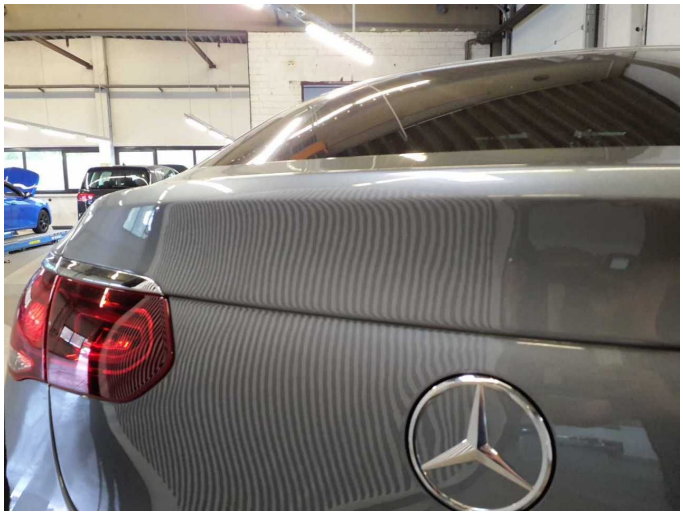
Boot lid / rear door	1,360 µm

Repainting 1: Boot lid / rear door

Boot lid / rear door: 1,360 µm
