TÜV SÜD Auto Partner GmbH
Wiesenring 2
04159 Leipzig

# Expertise

Protocol number: 48472904
Order No. / Reference: 27156161-1
Inspection date: 28 Oct 2026

| Manufacturer: Volkswagen | Model: Passat Variant 1.4 TSI Plug-In-Hybrid DSG GTE |

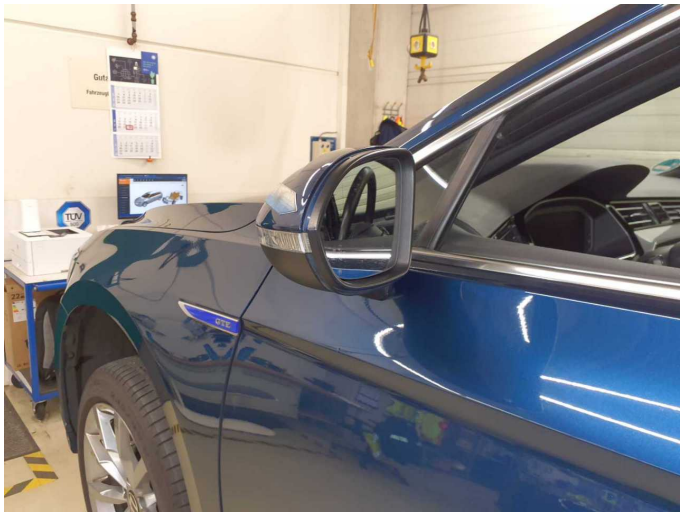
| No. | Component group | Description |
|---|---|---|
| 1 | Wing mirror - left side | Cap - Scratch(es) - Smart repair |

**Damage 1:** Wing mirror - left side: Cap - Scratch(es) - Smart repair

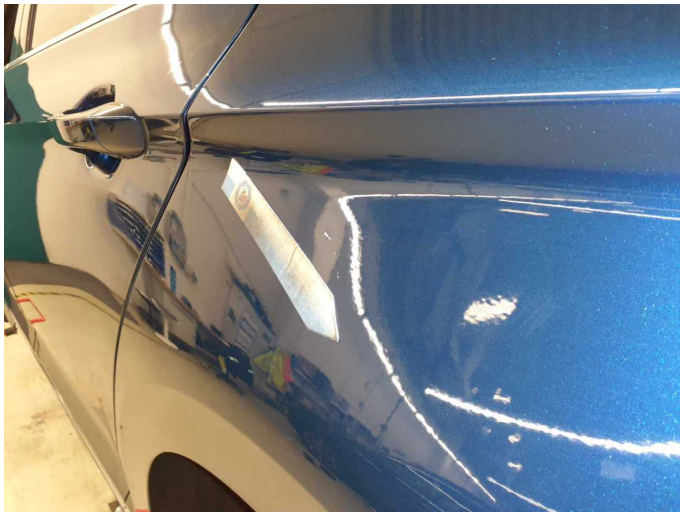
| No. | Component group | Description |
|---|---|---|
| 3 | Wheel / tyres | Alloy rim - rear left side - Scratched - Loss in value |
| 4 | Side panel - rear left side | Side panel - Dent / paintcoat damage - Smart repair |

**Damage 3:** Wheel / tyres: Alloy rim - rear left side - Scratched - Loss in value

**Damage 4:** Side panel - rear left side: Side panel - Dent / paintcoat damage - Smart repair

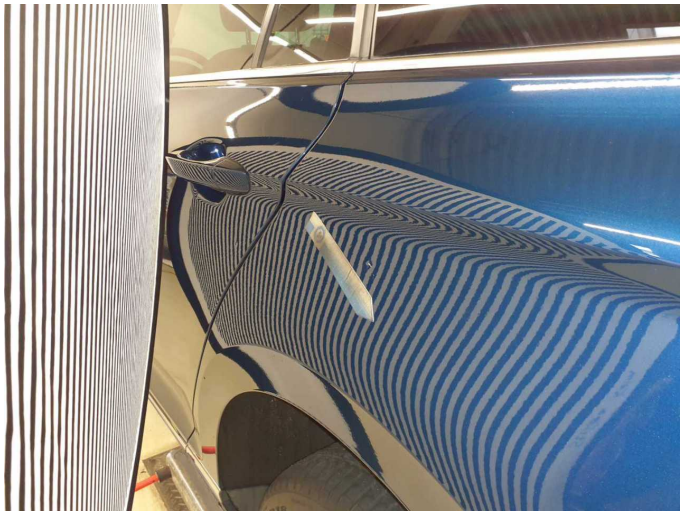
**Damage 4:** Side panel - rear left side: Side panel - Dent / paintcoat damage - Smart repair

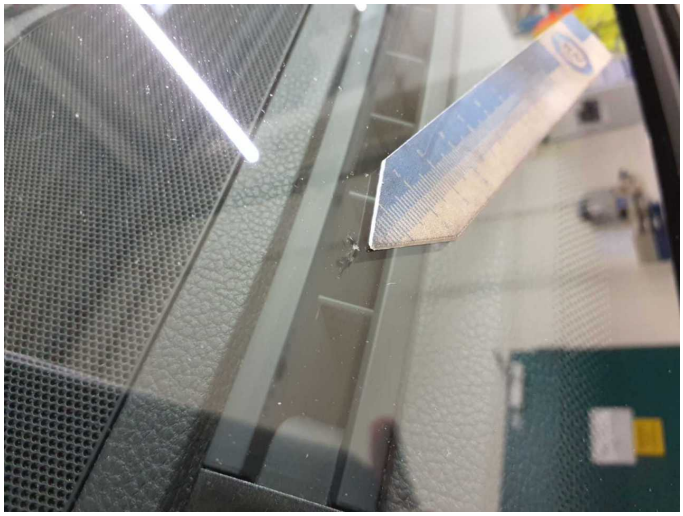
| No. | Component group | Description |
|---|---|---|
| 7 | Vehicle glazing | Windscreen - Stone chips - repair according to calculation |

**Damage 7:** Vehicle glazing: Windscreen - Stone chips - repair according to calculation

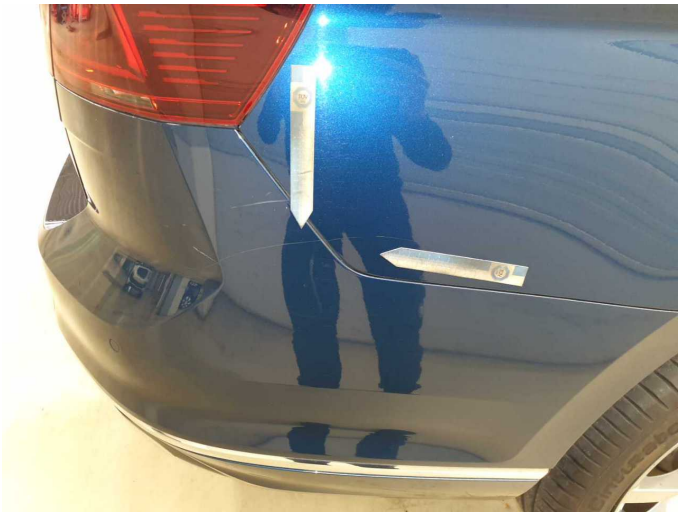
| No. | Accident |
|---|---|
| 1 | Rear, Side right |

**Accident 1:** Rear, Side right
