Expertise

Protocol number: 48513486
Order No. / Reference: 27212509
Inspection date: 29 Oct 2026

Manufacturer: Opel	Model: Mokka 1.2 DI Turbo Automatik Elegance
VIN: VXKUSHNSSNW046244

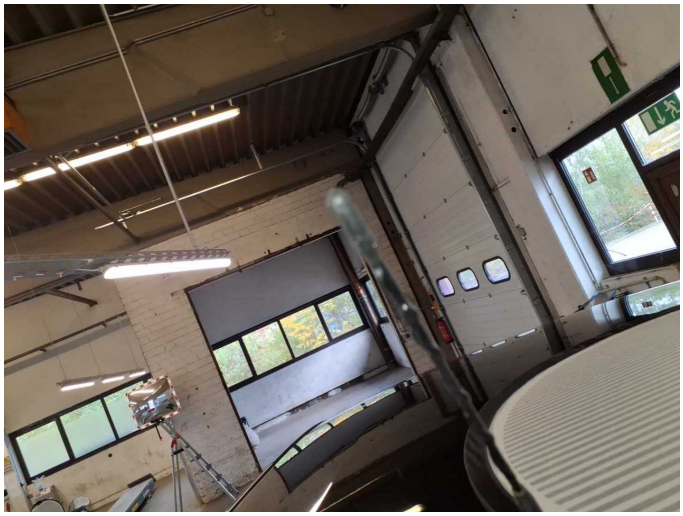
Damage 3: Roof: Stub aerial (Bissspuren) - Damage caused by marten / rodent - Replace

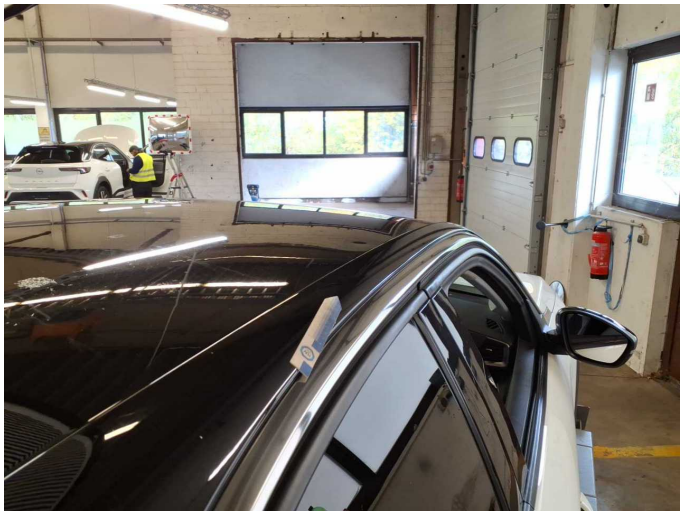
Damage 11: Roof: Roof rail - right side - dent(s) - Smooth repair work

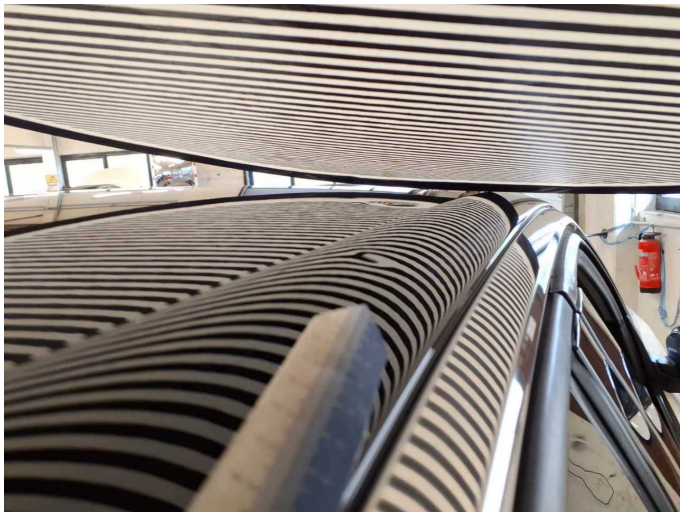
Damage 11: Roof: Roof rail - right side - dent(s) - Smooth repair work

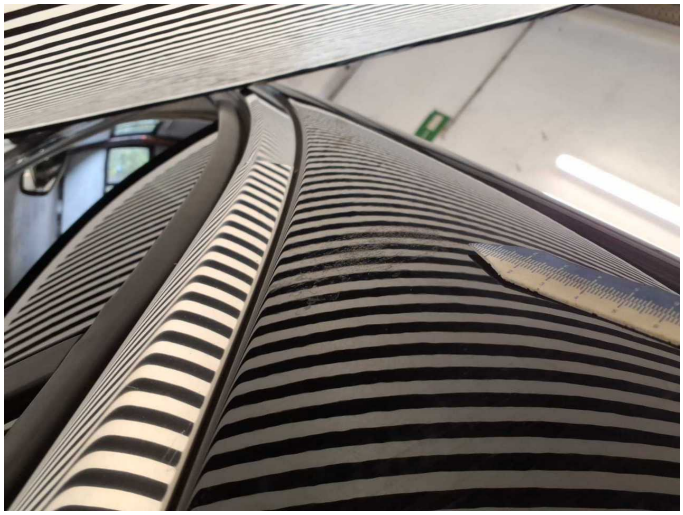
Damage 19: Roof: Roof rail - left side (Einätzungen, Mehrkosten sind möglich) - Paint defect - Conditioning

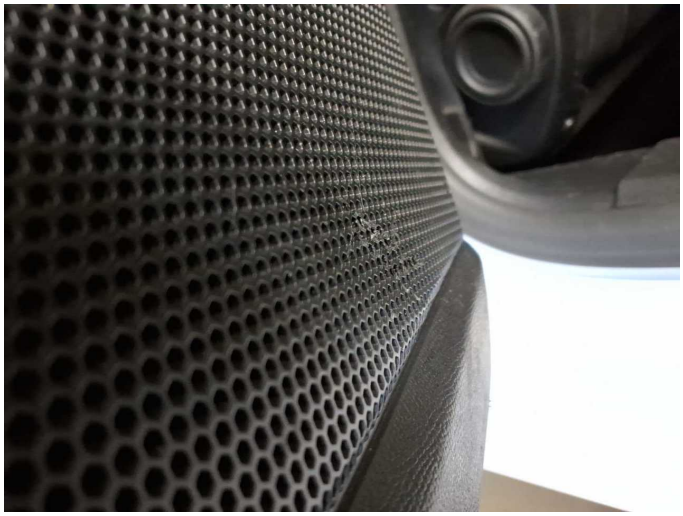
Damage 20: Trim / covers: Door trim - rear left side - Scratched - Replace

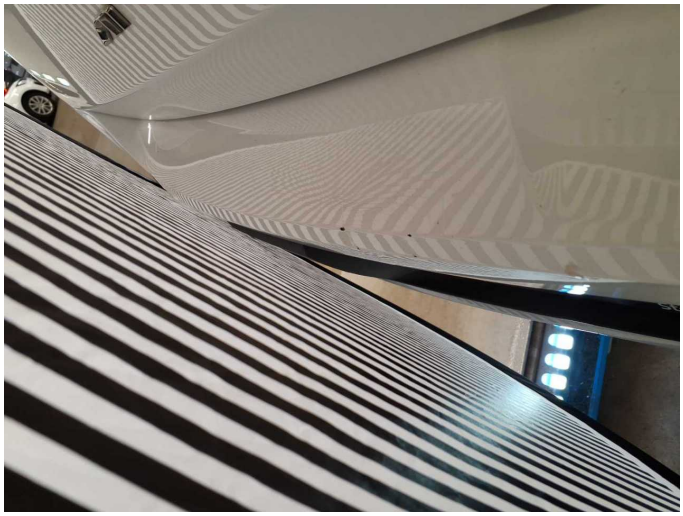
Damage 23: Rear bumper: Rear bumper (Verkratzt) - Deformed - Repair and paint

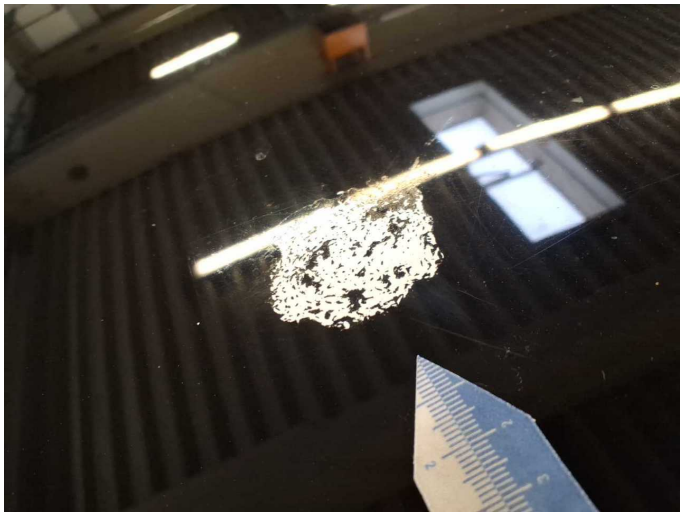
Damage 25: Bonnet: Bonnet - Dent / paintcoat damage - Repair and paint

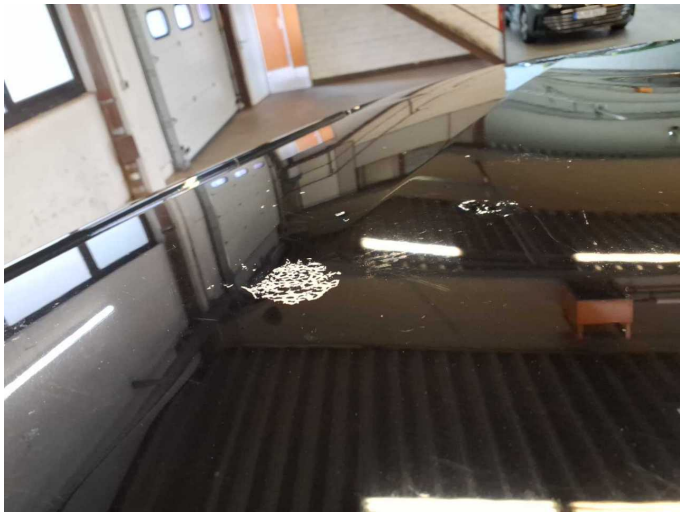
Damage 26: Roof: Roof (Einätzungen,Dellen, Farbe o.ä) - Paint defect - Paint

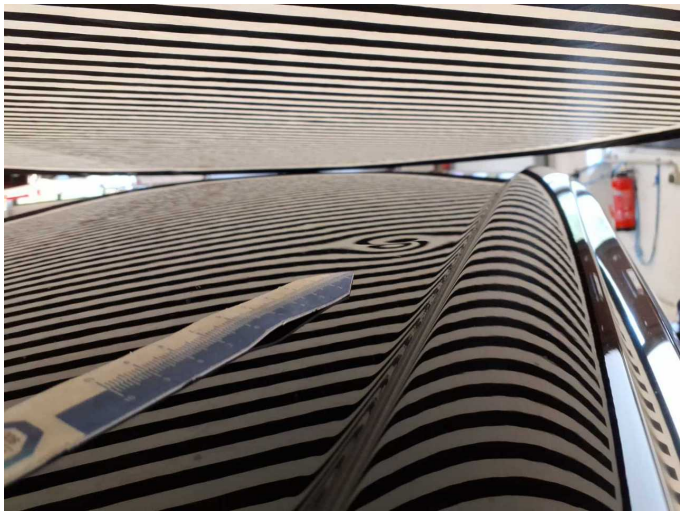
Damage 26: Roof: Roof (Einätzungen,Dellen, Farbe o.ä) - Paint defect - Paint

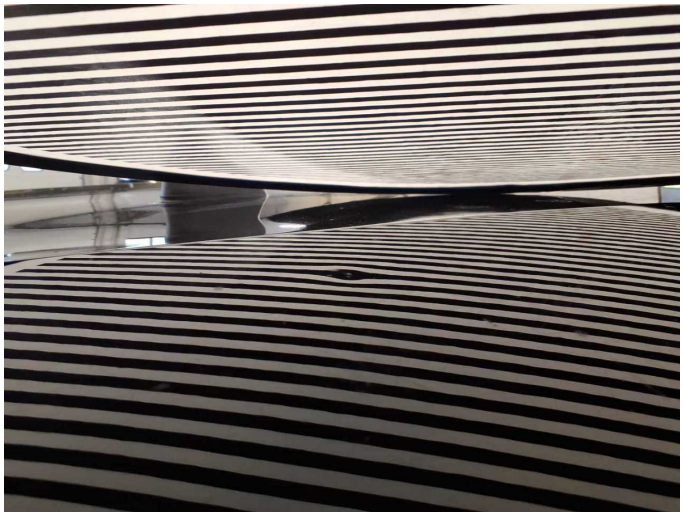
Damage 26: Roof: Roof (Einätzungen,Dellen, Farbe o.ä) - Paint defect - Paint
