TÜV SÜD Auto Partner GmbH
Wiesenring 2
04159 Leipzig

Expertise

Protocol number: 47604131
Order No. / Reference: 26915260
Inspection date: 15 Sept 2026

Manufacturer: Mercedes-Benz	Model: C 200 d T 9G-TRONIC Avantgarde
VIN: W1KAH0DB8PF088690

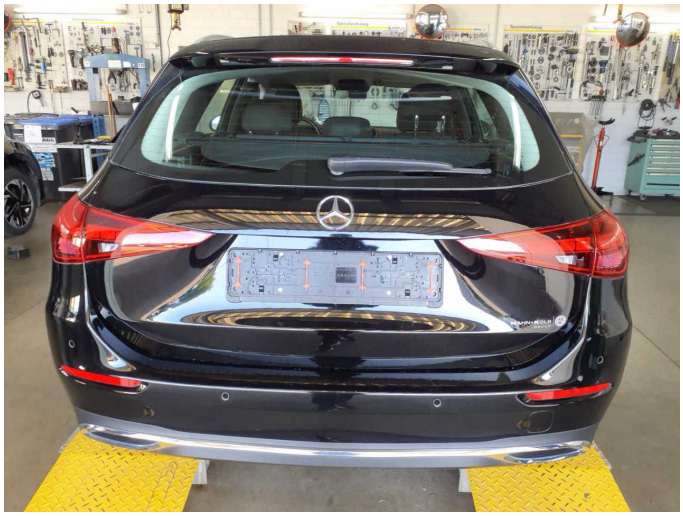
Damage 1: Boot lid / rear door: Boot lid - Glued / labelled - De-glue / neutralise

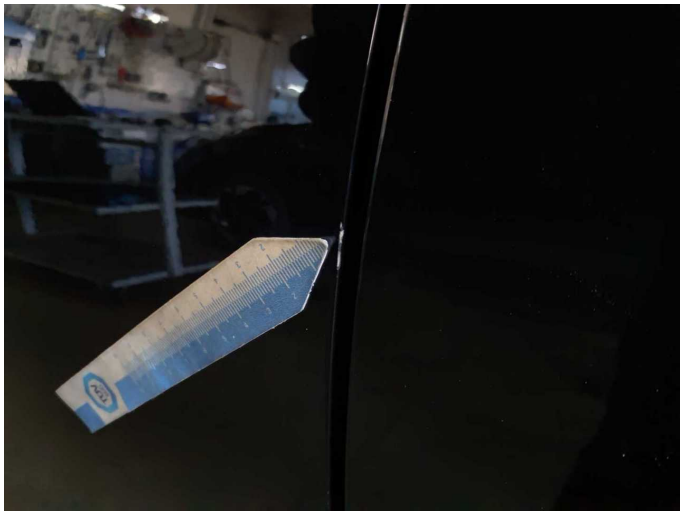
Damage 2: Door - front left side: Door edge - Scratch(es) - Smart repair

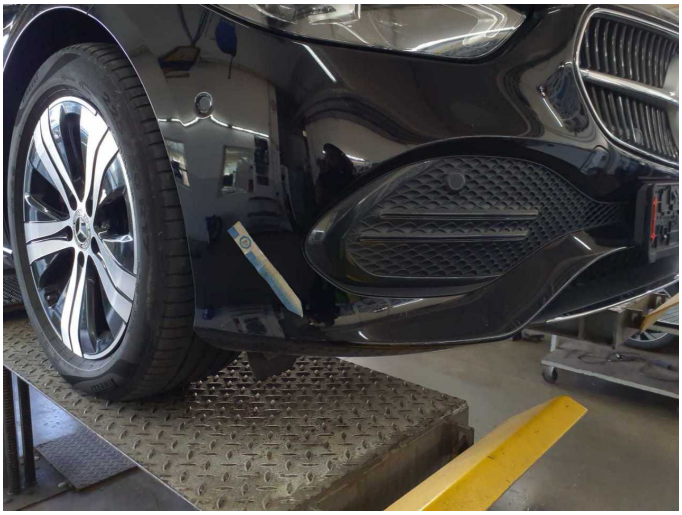
Damage 3: Front bumper: Front bumper - Scratch(es) - Repair and paint

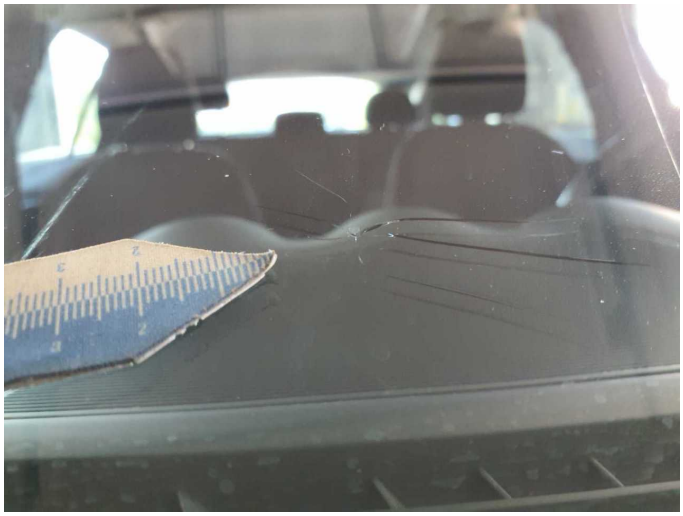
Damage 4: Vehicle glazing: Windscreen with lane departure assistant - Broken / torn - Replace
