ARVAL
BNP PARIBAS GROUP

2CKF393

# INSPECTION REPORT

**End of contract**

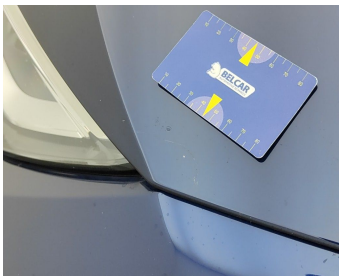
| Damages | Type | Acceptable |
|---|---|---|
| 136 | Bumper Rear // Polish | Y |

Bumper Rear // Polish-scratch

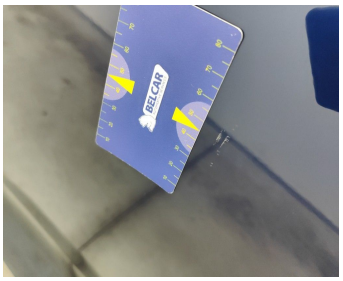
| Damages | Type | Acceptable |
|---|---|---|
| 18 | Bumper Front / Spoiler / Replace | Y |

Bumper Front / Spoiler / Replace-scratch

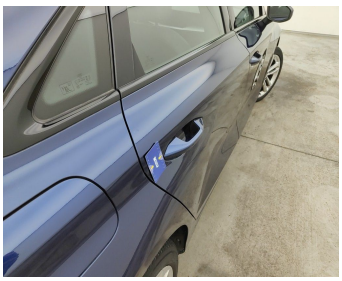
| Damages | Type | Acceptable |
|---|---|---|
| 83 | Door Front Left // Painting | Y |

Door Front Left // Painting-scratch
