Expertise

Protocol number: 47923192
Order No. / Reference: 27015006
Inspection date: 5 Oct 2026

Manufacturer: Mercedes-Benz	Model: GLE 350 e 4Matic 9G-TRONIC
VIN: W1NFB5EB2PA863231

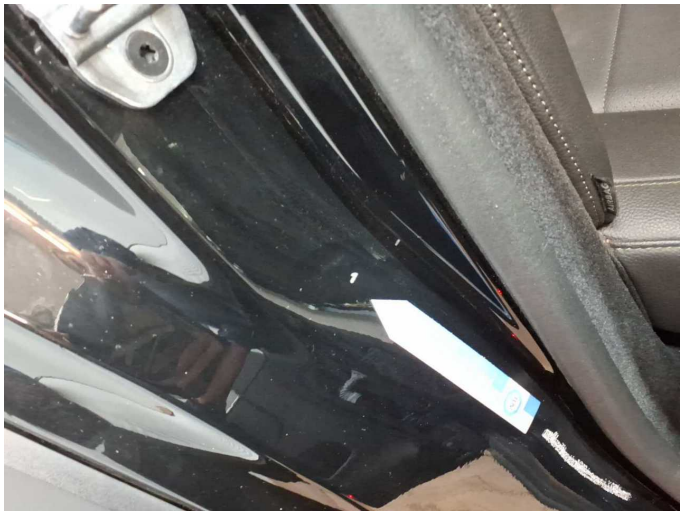
Damage 2: Side panel - rear right side: Sill - Scratch(es) - Smart repair

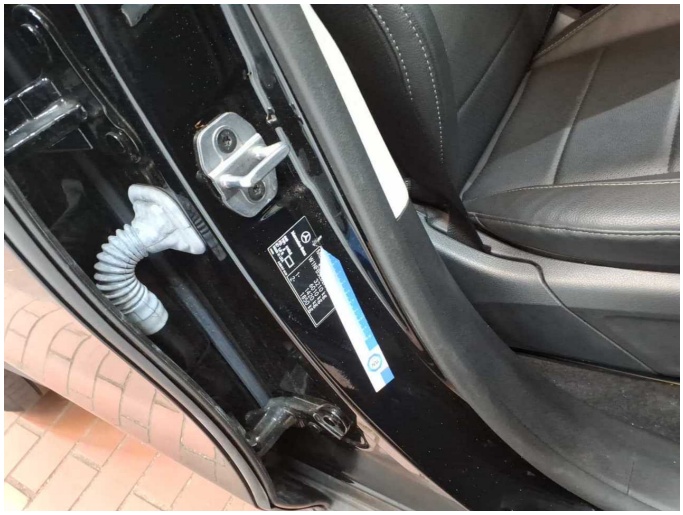
Damage 3: Body: B-pillar - right side - Scratch(es) - Smart repair

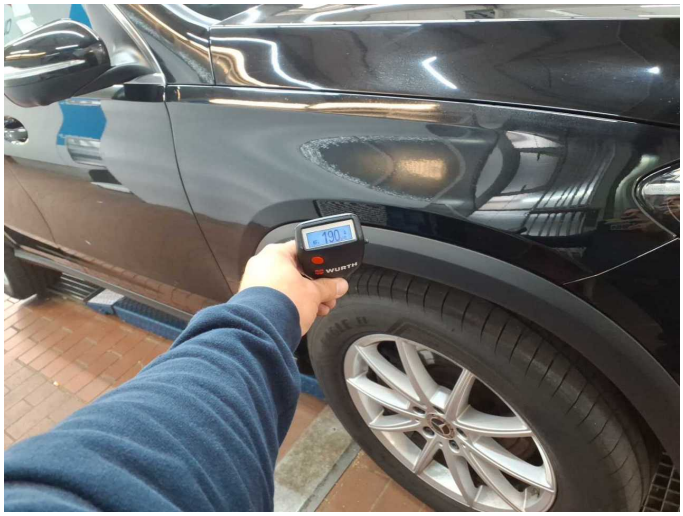
No.	Repainting
1	Mudguard - right side, Bonnet, Professionally carried out, Invoice of repair done Non-existent

Mudguard - right side	190 µm	Bonnet	223 µm

Repainting 1: Mudguard - right side, Bonnet
