TÜV SÜD Auto Partner GmbH
Wiesenring 2
04159 Leipzig

Expertise

Protocol number: 47389100
Order No. / Reference: 26745593
Inspection date: 28 Aug 2026

Manufacturer: Mercedes-Benz	Model: C 200 d T 9G-TRONIC
VIN: W1KAH0DB9PF120028

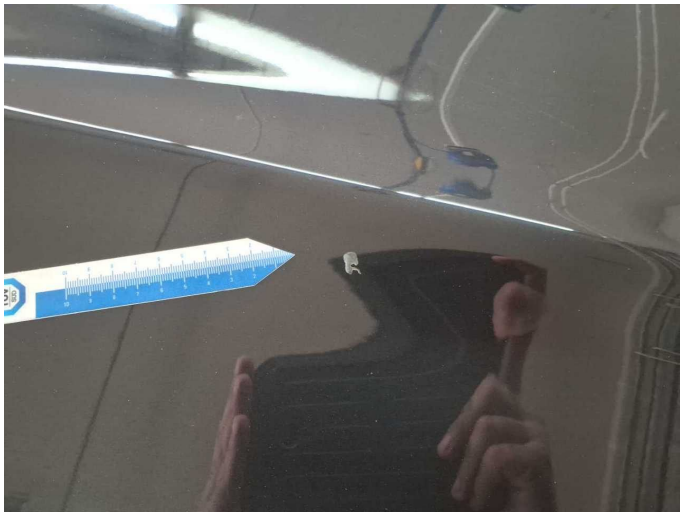
No.	Component group	Description
1	Trim / covers	Boot lining - Scratch(es) - Loss in value
2	Door - front left side	Door edge - Scratch(es) - Smart repair
3	Bonnet	Bonnet (Harz) - Paint defect - Conditioning
4	Side panel - rear right side	Side panel - Scratch(es) - Smart repair
5	Rear bumper	Rear bumper - Scratch(es) - Paint

Damage 2: Door - front left side: Door edge - Scratch(es) - Smart repair

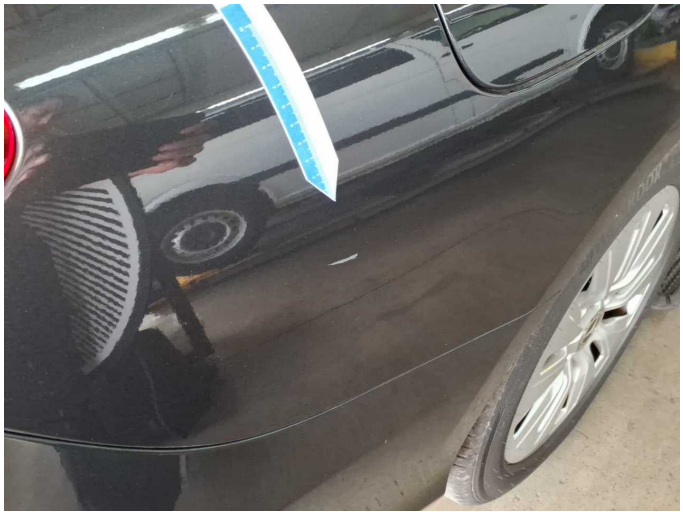
Damage 4: Side panel - rear right side: Side panel - Scratch(es) - Smart repair

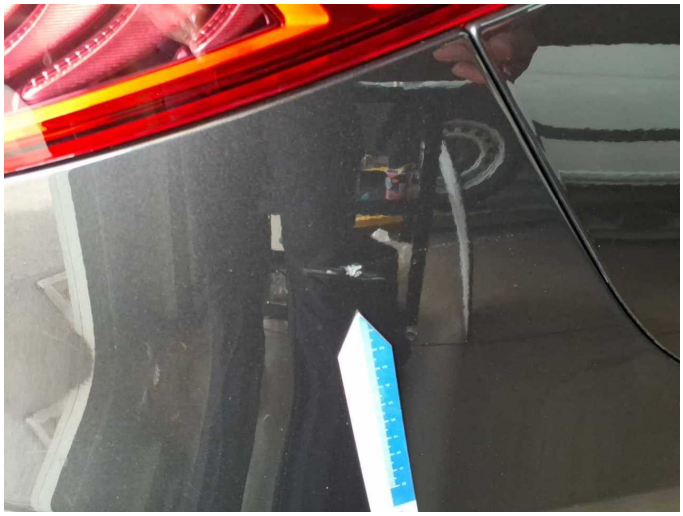
Damage 5: Rear bumper: Rear bumper - Scratch(es) - Paint

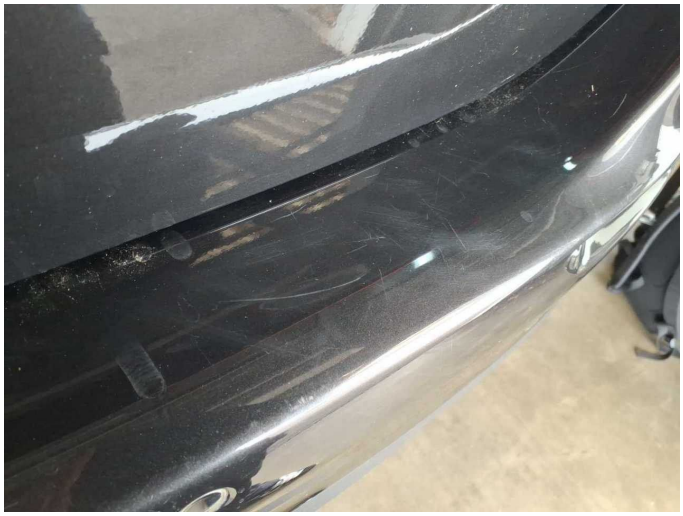
Damage 5: Rear bumper: Rear bumper - Scratch(es) - Paint
