Expertise

Protocol number: 48413793
Order No. / Reference: 27162637
Inspection date: 21 Oct 2026

Manufacturer: Volkswagen	Model: Caddy Cargo 2.0 TDI BMT Kasten
VIN: WV1ZZZSKZMX059404

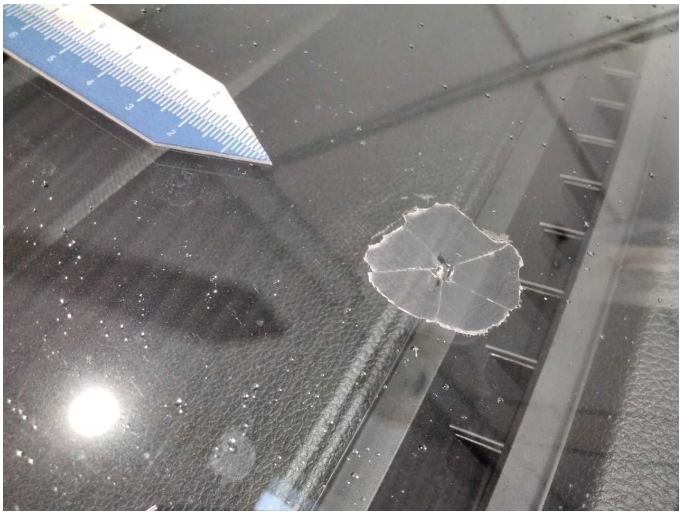
Damage 5: Vehicle glazing: Windscreen - Stone chips - Replace
