TÜV SÜD Auto Partner GmbH
Wiesenring 2
04159 Leipzig

Expertise

Protocol number: 48070873
Order No. / Reference: 27080820
Inspection date: 12 Oct 2026

Manufacturer: Mercedes-Benz	Model: GLB 200 d 8G-DCT Progressive
VIN: W1N4M1CB8PW284695

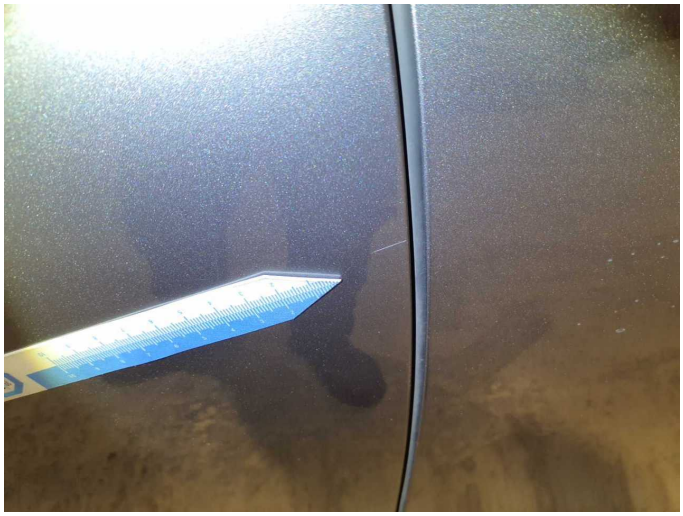
Damage 4: Side panel - rear left side: Sill - Scratch(es) - Smart repair

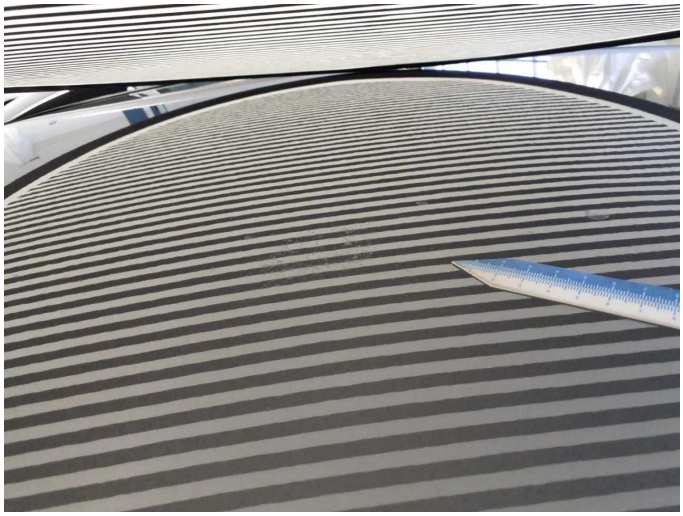
- Das Fahrzeug weißt eine/mehrere Anätzungen auf. Die Schadensumme kann sich somit erhöhen oder erweitern.

Damage 9: Roof: Roof (Anätzung) - Paint defect - Conditioning

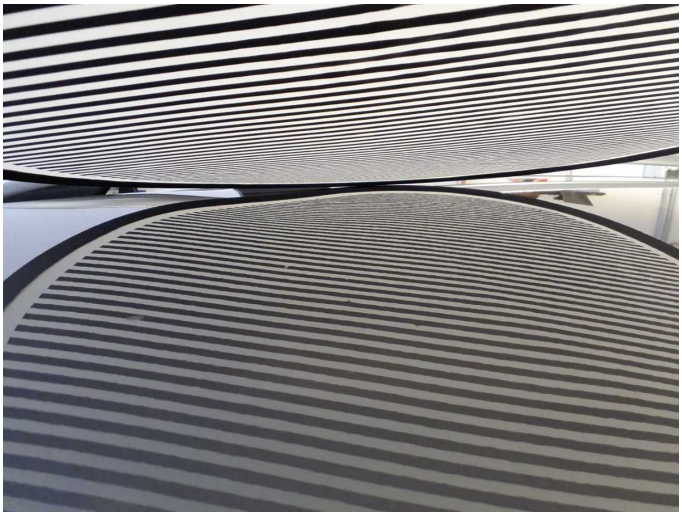
Damage 9: Roof: Roof (Anätzung) - Paint defect - Conditioning
