Expertise

Protocol number: 48583263
Order No. / Reference: 27244693
Inspection date: 9 Nov 2026

Manufacturer: Mercedes-Benz	Model: GLC 300 de 4Matic 9G-TRONIC AMG Line
VIN: W1N2539111V313986

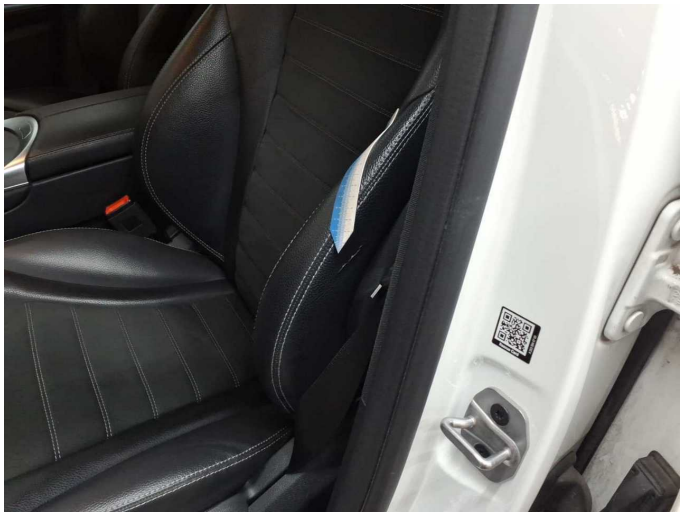
No.	Component group	Description
1	Seat - front	Seat cover - right side - Abrasion - Loss in value
2	Seat - front	Seat cover - left side - Broken / torn - Replace
3	Bonnet	Bonnet - Corrosion - Paint

Damage 1: Seat - front: Seat cover - right side - Abrasion - Loss in value

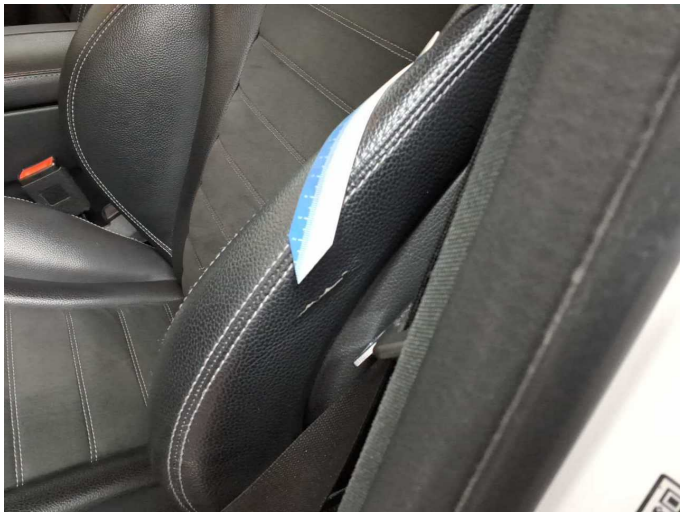
Damage 2: Seat - front: Seat cover - left side - Broken / torn - Replace

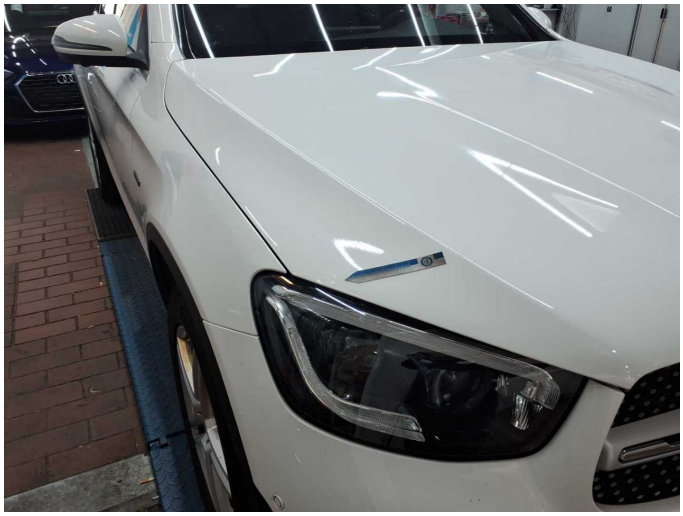
Damage 3: Bonnet: Bonnet - Corrosion - Paint
