MACADAM

Polestar Polestar 2 '19 BEV

Vehicle information

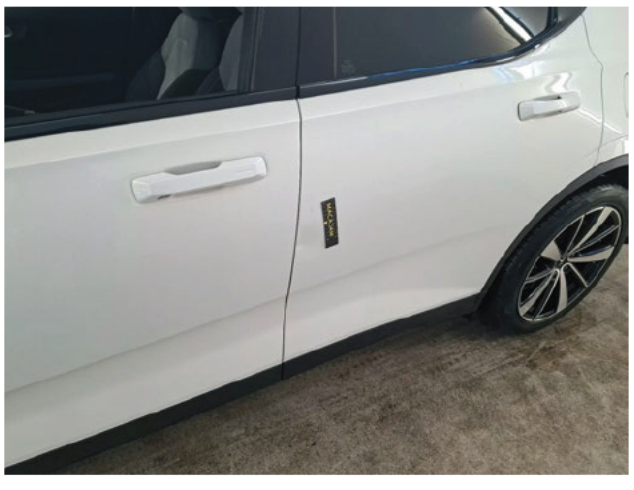
Alloy rim FL
Scratch(es)
Repair and paint (complete)
Left

Alloy rim FR
Scratch(es)
Repair and paint (complete)
Right
