TÜV SÜD Auto Partner GmbH
Gutenbergstraße 13
70771 Leinfelden-Echterdingen

Expertise

Protocol number: 48565372
Order No. / Reference: 27290548
Inspection date: 6 Nov 2026

Manufacturer: Volkswagen	Model: Crafter 35 TDI VA
VIN: WV1ZZZSYZL9057211

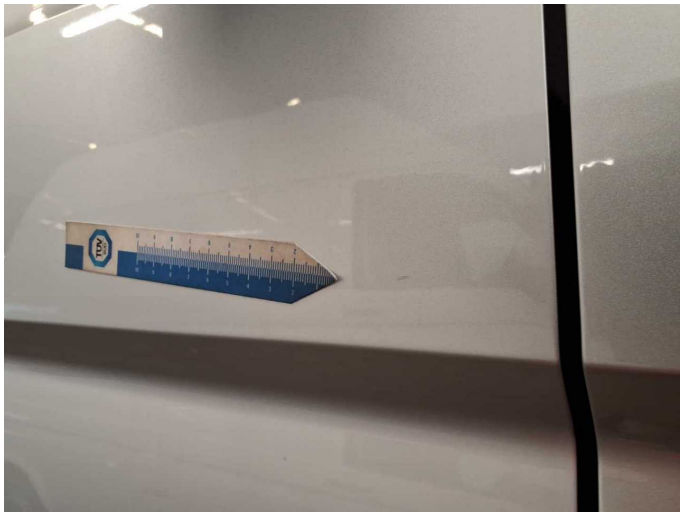
Damage 2: Boot lid / rear door: Boot lid - dent(s) - Smooth repair work

Damage 3: Front bumper: Front bumper (unpainted) - Scratch(es) - Loss in value
