TÜV SÜD Auto Partner GmbH
Wiesenring 2
04159 Leipzig

Expertise

Protocol number: 48499270
Order No. / Reference: 27242509
Inspection date: 4 Nov 2026

Manufacturer: Opel	Model: Vivaro 2.0 D Cargo L EHZ Autm. Edition
VIN: VXEVFEHS7MZ111421

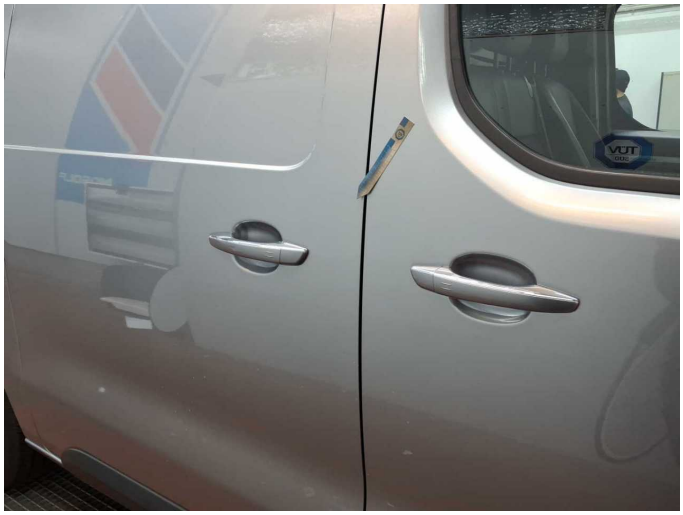
No.	Component group	Description
1	Equipment	Tirefit filler - Expired - Replace
2	Side panel - rear left side	Side panel - Dent / paintcoat damage - Loss in value
3	Door - front right side	Door - Scratch(es) - Smart repair
4	Sliding door, right	Sliding door - Scratch(es) - Smart repair
5	Boot lid / rear door	Rear door - right side - Deformed - Repair and paint

Damage 3: Door - front right side: Door - Scratch(es) - Smart repair
