ARVAL
BNP PARIBAS GROUP

2EAJ389

INSPECTION REPORT

End of contract

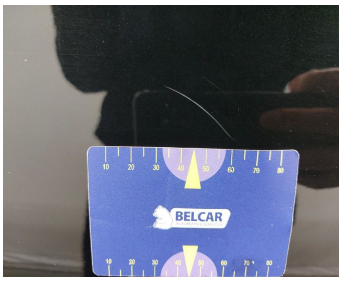
Trunk Lid Interior Coating / Complete Panel / Replace-scratch

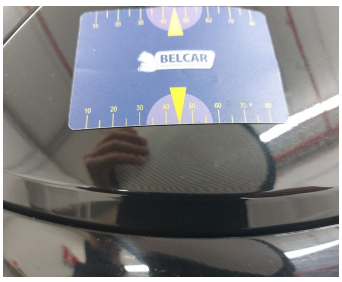
Front Bonnet // Polish-scratch

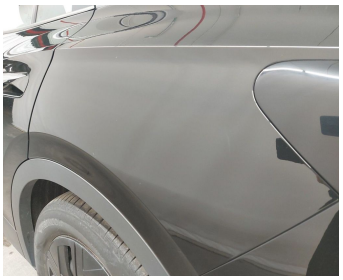
Wing Rear Left // Repair & Painting-scratch + dent
