TÜV SÜD Auto Partner GmbH
Wiesenring 2
04159 Leipzig

Expertise

Protocol number: 48418504
Order No. / Reference: 27188857
Inspection date: 29 Oct 2026

Manufacturer: Mercedes-Benz	Model: C 220 d T 9G-TRONIC
VIN: W1K2062161F029215

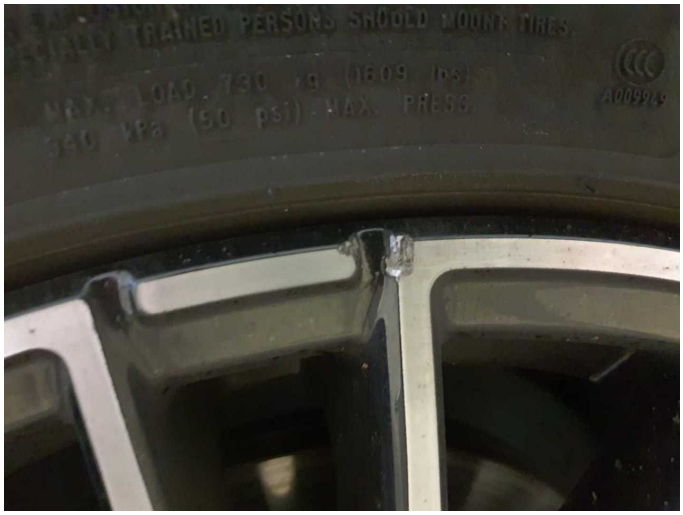
Damage 2: Wheel / tyres: Alloy rim - rear right side - Scratch(es) - Loss in value

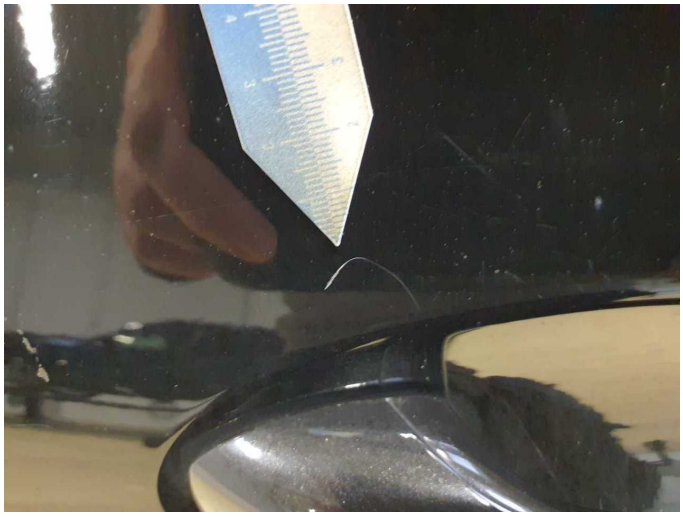
Damage 5: Side panel - rear right side: Sill - Scratch(es) - Smart repair

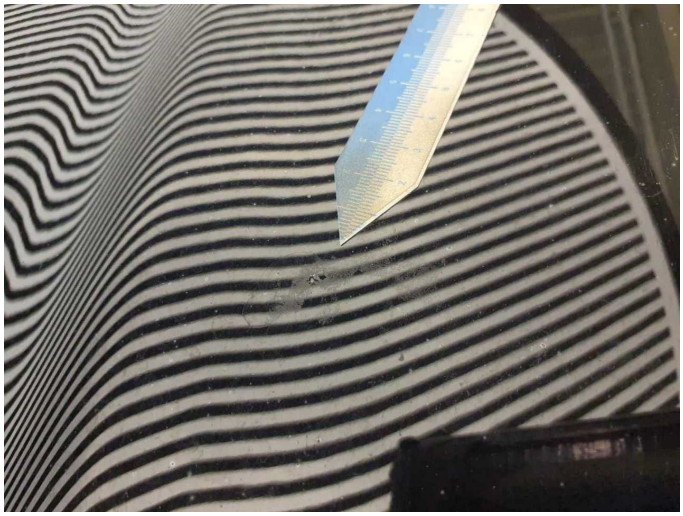
Damage 7: Bonnet: Bonnet (Anätzung-Mehrkosten möglich) - Paint defect - Conditioning

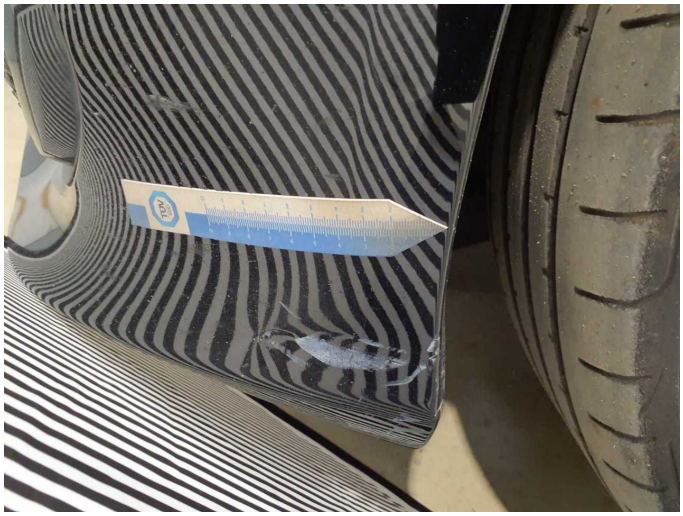
Die beigefügte Reparaturkostenkalkulation wurde nach bestem Wissen und Gewissen unter eingeschränkten Besichtigungsbedingung im demontagefreien Zustand erstellt. Es können aufgrund verdeckter Beschädigung, Mehrkosten und somit Abweichung der für die Stoßstange ausgewiesenen Reparaturkosten nicht ausgeschlossen werden.

Damage 10: Front bumper: Front bumper - Broken / torn - Replace
