Expertise

Protocol number: 48220124
Order No. / Reference: 27117318
Inspection date: 20 Oct 2026

Manufacturer: Mercedes-Benz	Model: EQB 300 4Matic AMG Line
VIN: W1N9M0JB3PN037352

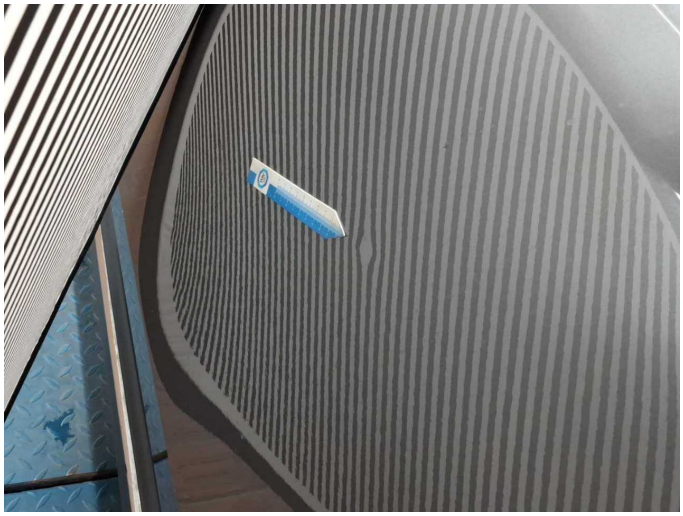
No.	Component group	Description
1	Door - front right side	Door - dent(s) - Smooth repair work

Damage 1: Door - front right side: Door - dent(s) - Smooth repair work
