ARVAL
BNP PARIBAS GROUP

2FAW596

INSPECTION REPORT

End of contract

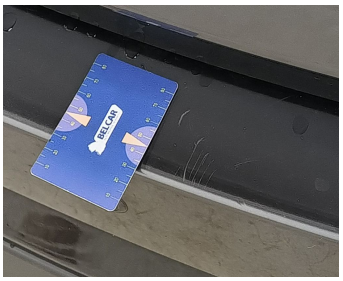
Door Front Right // Repair & Painting-scratch + dent
