Expertise

Protocol number: 48547189
Order No. / Reference: 27174914
Inspection date: 4 Nov 2026

Manufacturer: Mercedes-Benz	Model: Vito 116 CDI Extralang HA BASE
VIN: W1V44760513981415

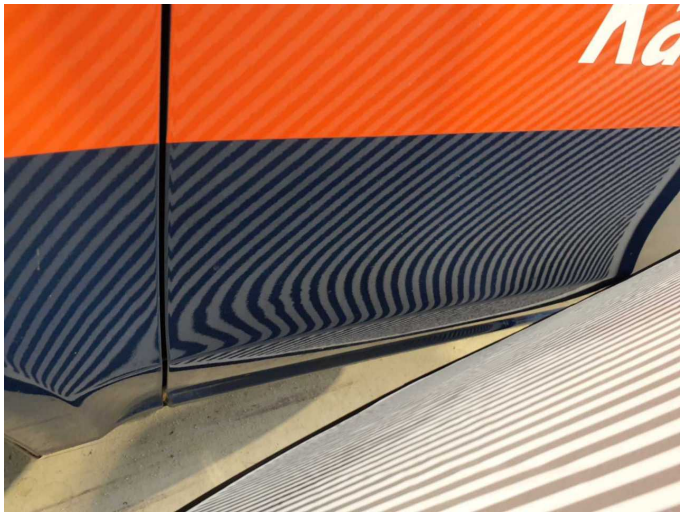
Damage 5: Door - front left side: Door - Dent / paintcoat damage - Smart repair

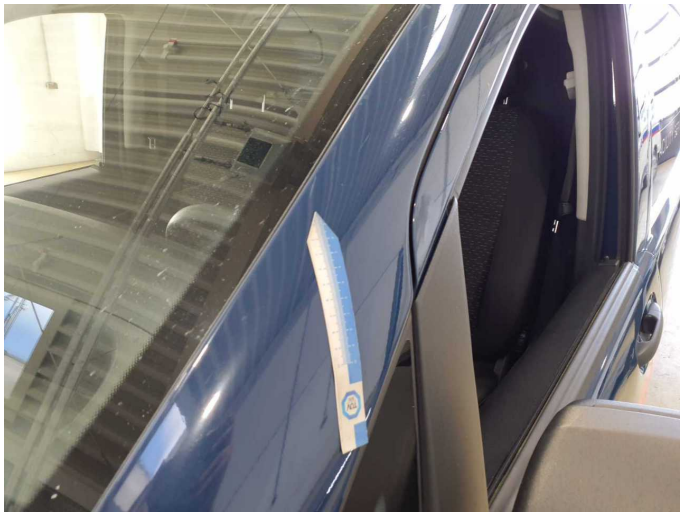
Damage 6: Body: A-pillar - left side - Scratch(es) - Smart repair

Damage 7: Door - front right side: Door - Dent / paintcoat damage - Smart repair

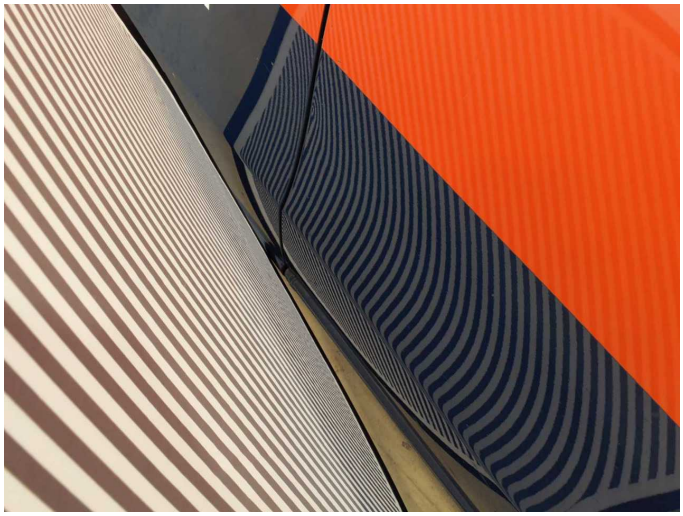
Damage 7: Door - front right side: Door - Dent / paintcoat damage - Smart repair

Damage 8: Instrument panel: Air nozzle - centre - Broken / torn - Replace

Damage 9: Body: Body - Glued / labelled - De-glue / neutralise

Damage 10: Rear axle: Shock absorber - left side (Links und rechts) - Leaking - Replace

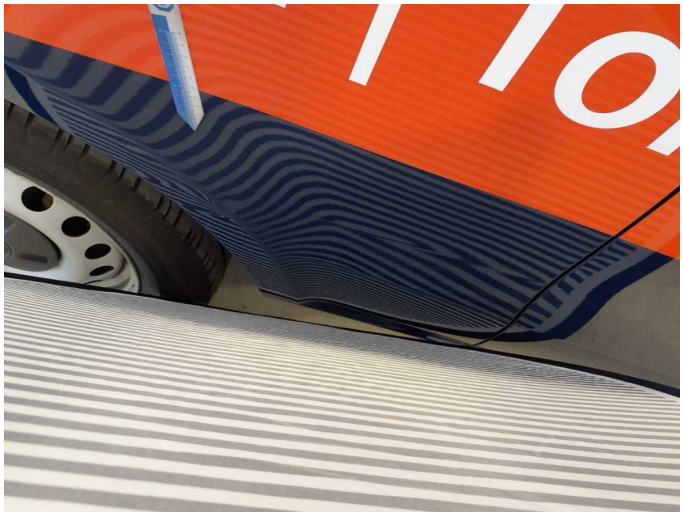
Damage 11: Side panel - rear right side: Side panel (unterhalb) - Dent / paintcoat damage - Repair and paint

Damage 12: Bonnet: Bonnet - Dent / paintcoat damage - Repair and paint

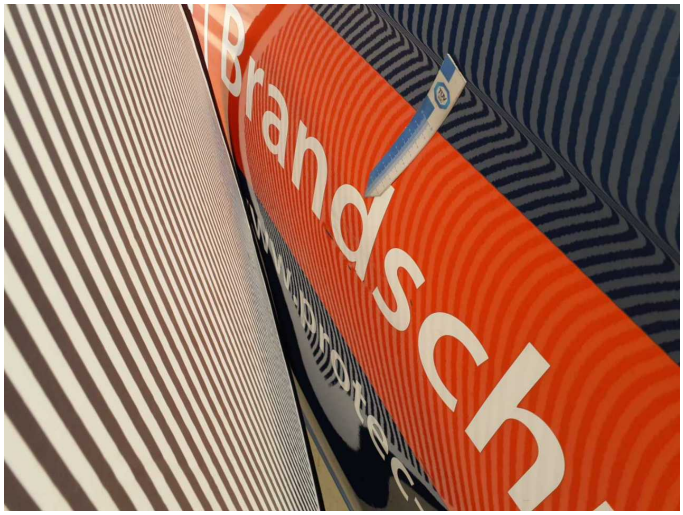
Damage 13: Sliding door, right: Sliding door - Dent / paintcoat damage - Repair and paint

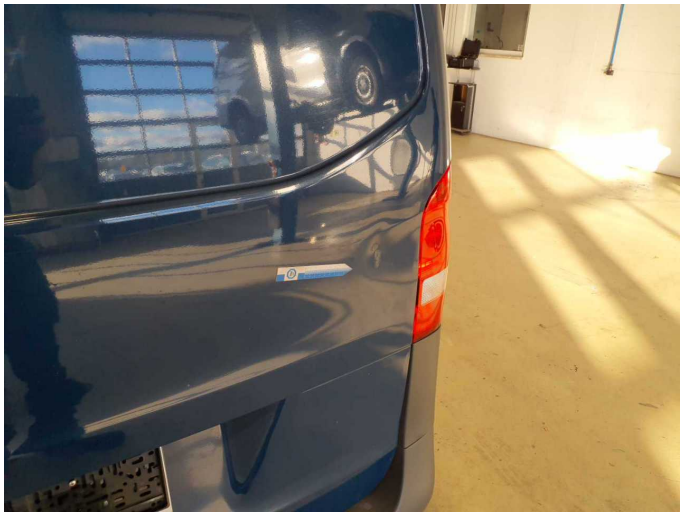
Damage 13: Sliding door, right: Sliding door - Dent / paintcoat damage - Repair and paint

Damage 14: Boot lid / rear door: Boot lid - Dent / paintcoat damage - repair according to calculation

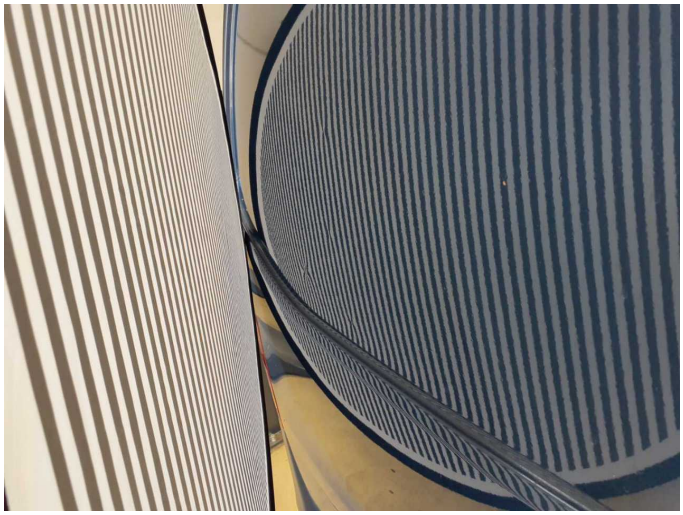
Damage 14: Boot lid / rear door: Boot lid - Dent / paintcoat damage - repair according to calculation

Damage 15: Roof: Roof - Dent / paintcoat damage - repair according to calculation

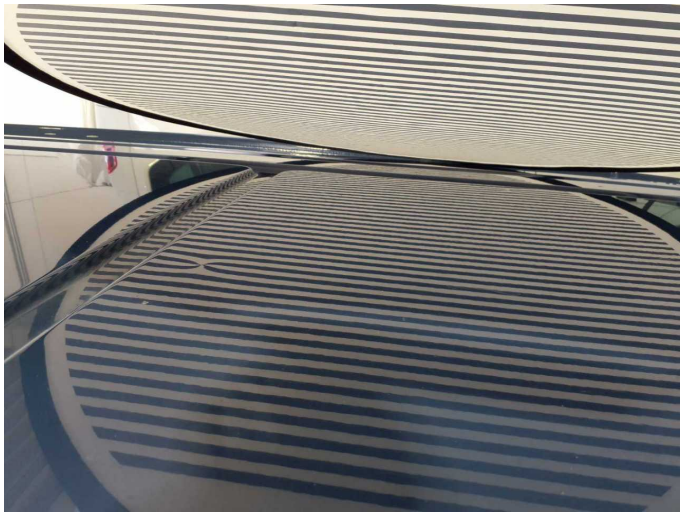
Damage 15: Roof: Roof - Dent / paintcoat damage - repair according to calculation

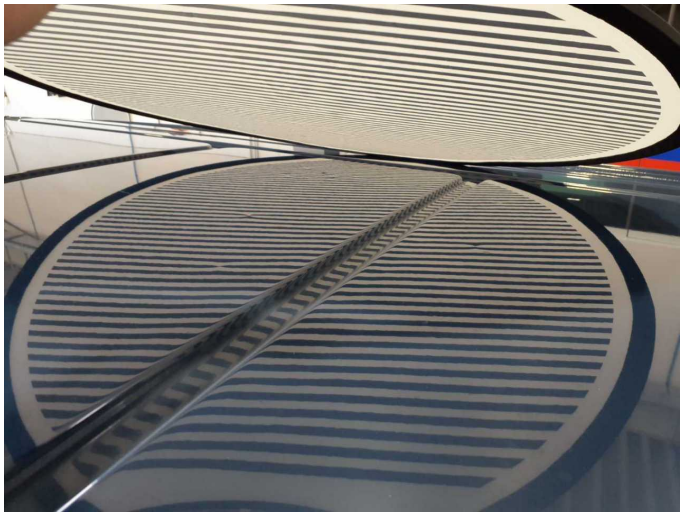
Damage 15: Roof: Roof - Dent / paintcoat damage - repair according to calculation

Wear and tear 2: Wing mirror - left side: Cap - Scratch(es) - No deduction

Wear and tear 3: Gearbox: Selector lever - Porous / cracked - No deduction

Wear and tear 4: Vehicle glazing: Windscreen - Stone chips - No deduction

Wear and tear 5: Front bumper: Front bumper (unpainted) - Scratch(es) - No deduction
