Expertise

Protocol number: 48016982
Order No. / Reference: 27012693
Inspection date: 8 Oct 2026

Manufacturer: Volkswagen	Model: Golf 1.4 eHybrid OPF DSG Style
VIN: WVWZZZCD4PW308277

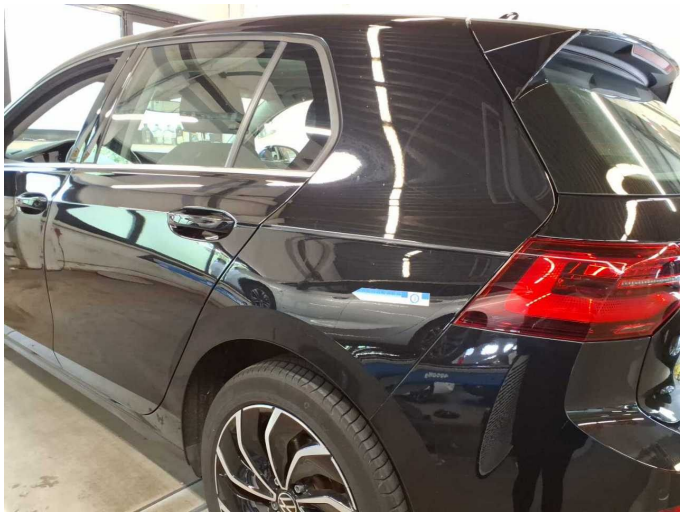
Damage 2: Door - rear right side: Door - dent(s) - Smooth repair work

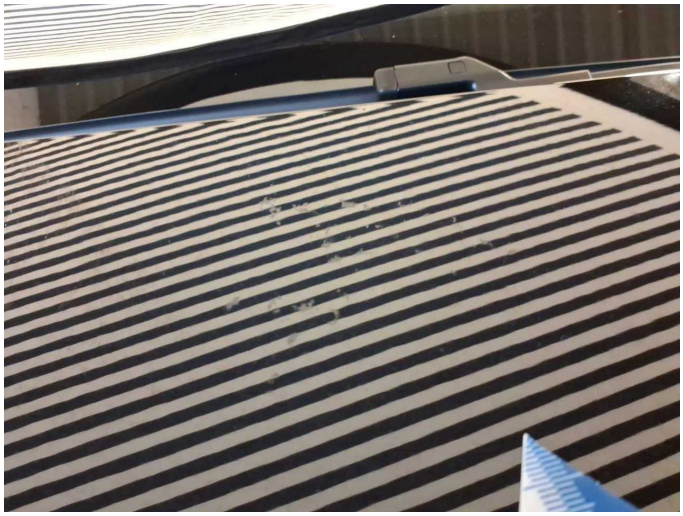
Damage 10: Bonnet: Bonnet (Durch Anätzung) - Paint defect - Paint

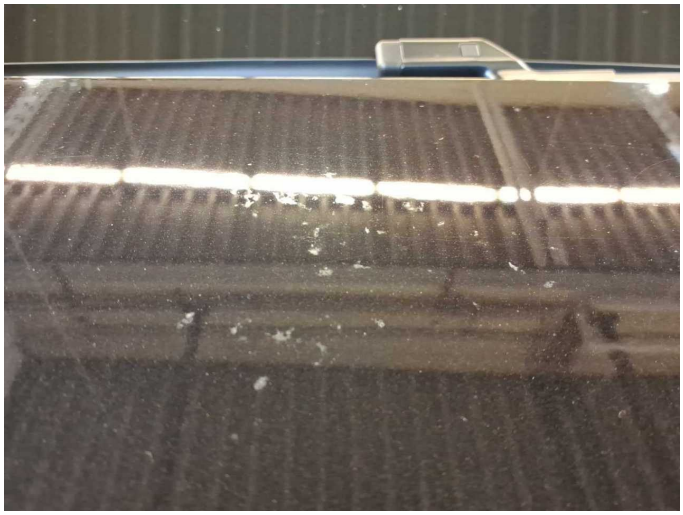
Damage 10: Bonnet: Bonnet (Durch Anätzung) - Paint defect - Paint
