Expertise

Protocol number: 46520239
Order No. / Reference: 26655365
Inspection date: 15 Jul 2026

Manufacturer: Ford	Model: Focus Turnier 1.5 EcoBlue Start-Stopp-System Aut. TITANIUM
VIN: WF0PXXGCHPPD74279

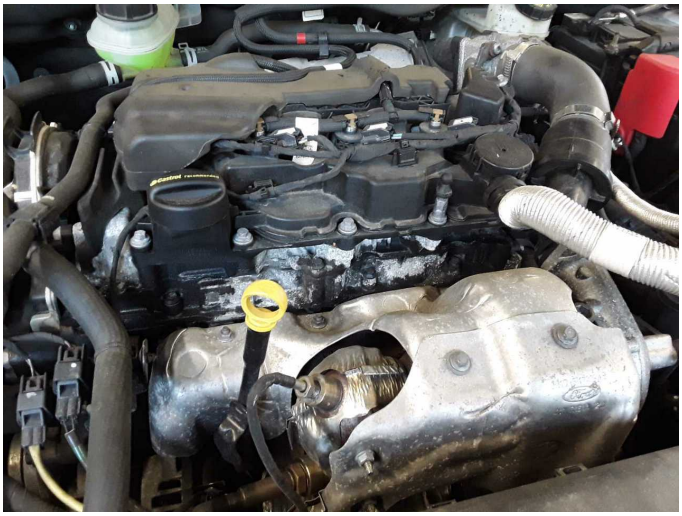
Damage 1: Engine: Engine cover - Damaged - Replace

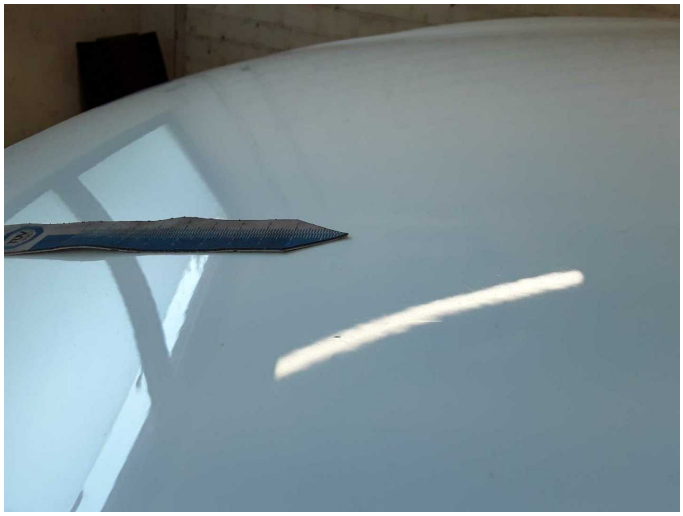
No.	Component group	Description
1	Engine	Engine cover - Damaged - Replace
2	Engine	Engine - Leaking - Perform diagnosis
3	Mudguard - left side	Mudguard - left side - Scratched - Paint
4	Side panel - rear right side	Side panel - Dent / paintcoat damage - Repair and paint
5	Bonnet	Bonnet - Scratched - Paint
6	Front bumper	Front bumper - Deformed - Replace

Damage 5: Bonnet: Bonnet - Scratched - Paint

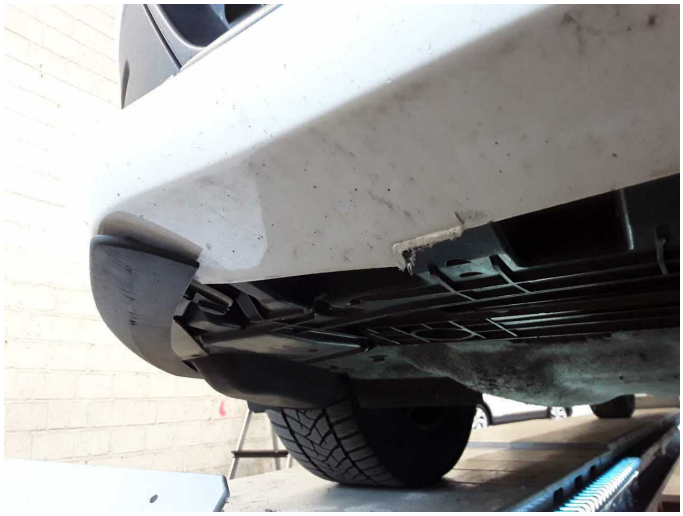
Damage 6: Front bumper: Front bumper - Deformed - Replace
