Expertise

Protocol number: 48368172
Order No. / Reference: 27217178
Inspection date: 27 Oct 2026

Manufacturer: Opel	Model: Insignia Sports Tourer 2.0 Diesel Business
VIN: W0VZT8GP4N1010604

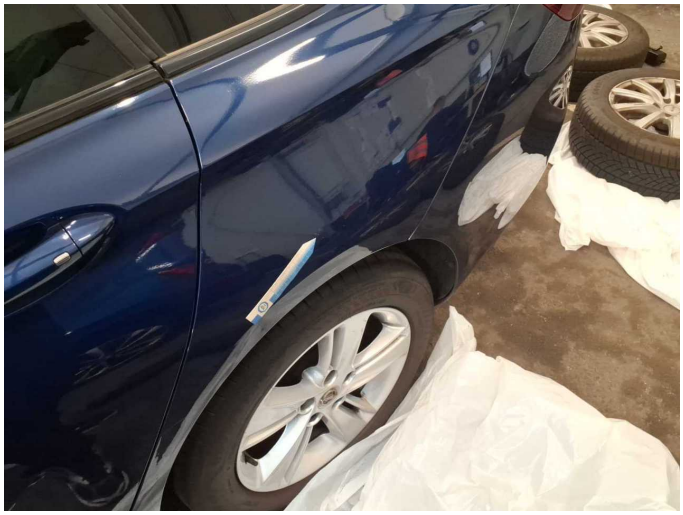
Damage 2: Side panel - rear right side: Side panel - Dent / paintcoat damage - Smart repair

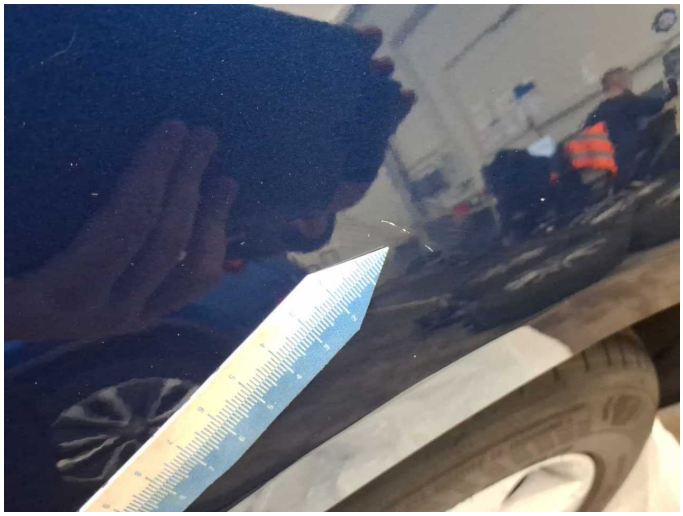
Damage 3: Side panel - rear left side: Side panel - Scratch(es) - Paint

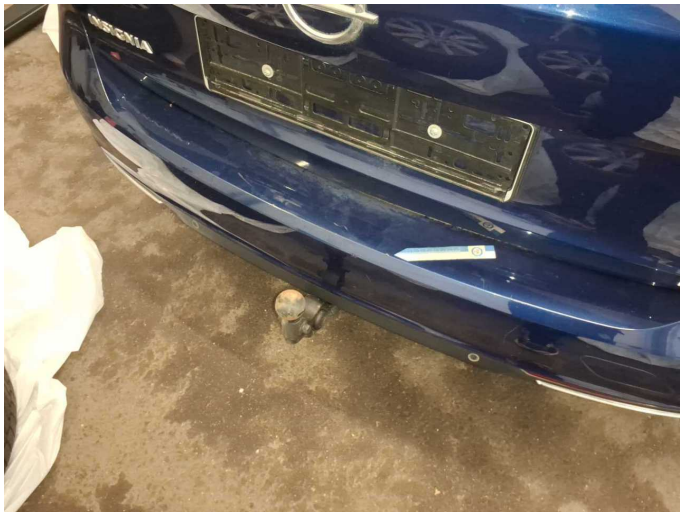
Damage 3: Side panel - rear left side: Side panel - Scratch(es) - Paint

Damage 4: Rear bumper: Rear bumper - Scratched - Repair and paint
