Expertise

Protocol number: 48411423
Order No. / Reference: 27192764
Inspection date: 27 Oct 2026

Manufacturer: Ford	Model: Transit Connect 230 L2 S&S Trend
VIN: WF07XXWPG7NY73424

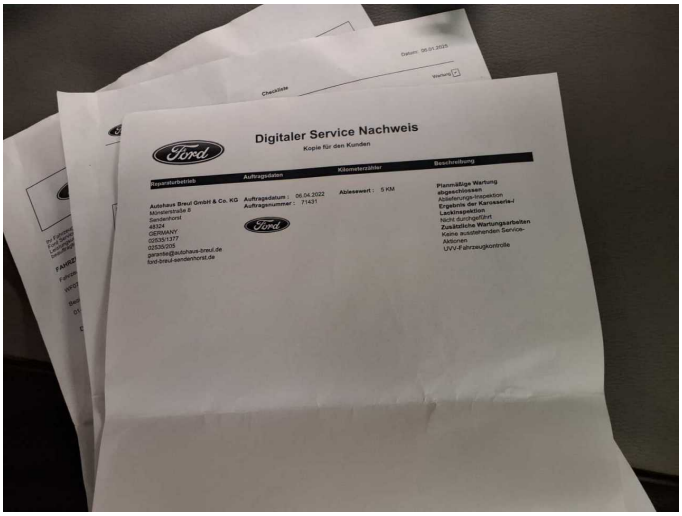
Damage 1: Misc.: Inspection / maintenance - Incomplete - No deduction

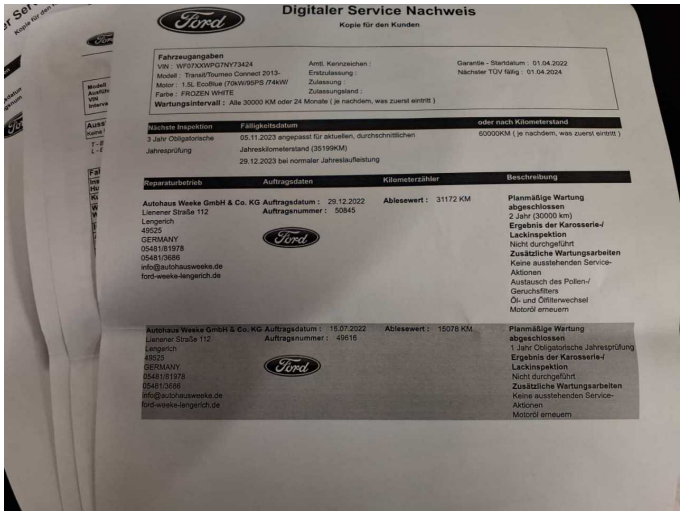
Damage 1: Misc.: Inspection / maintenance - Incomplete - No deduction

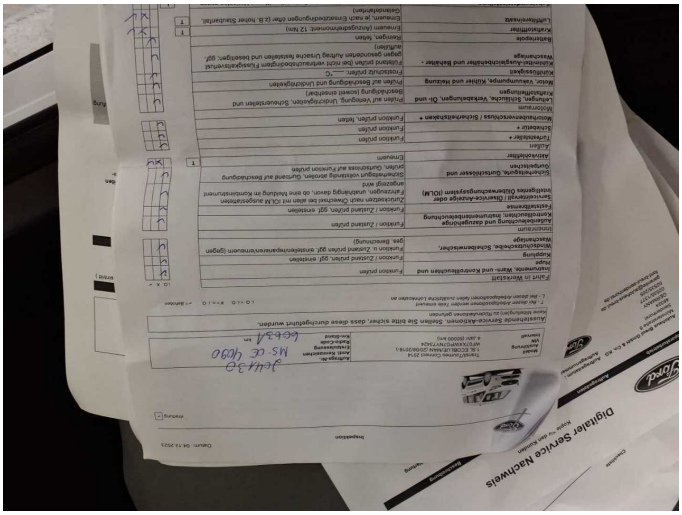
Damage 1: Misc.: Inspection / maintenance - Incomplete - No deduction

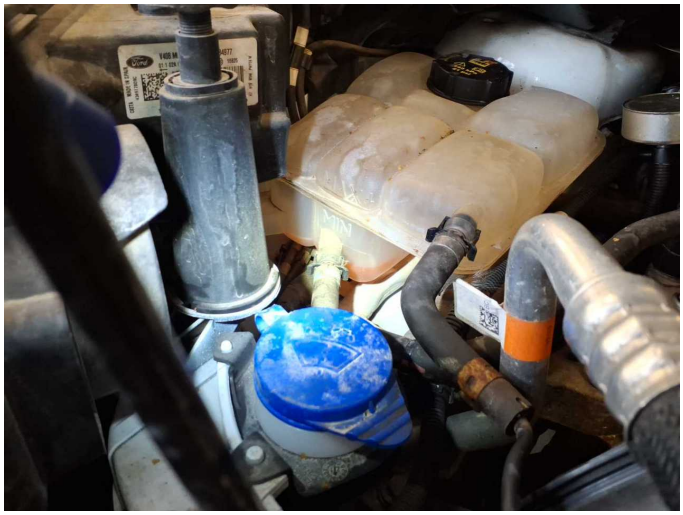
Damage 6: Engine cooling: Coolant (Weit unter minimum) - Missing - Perform diagnosis

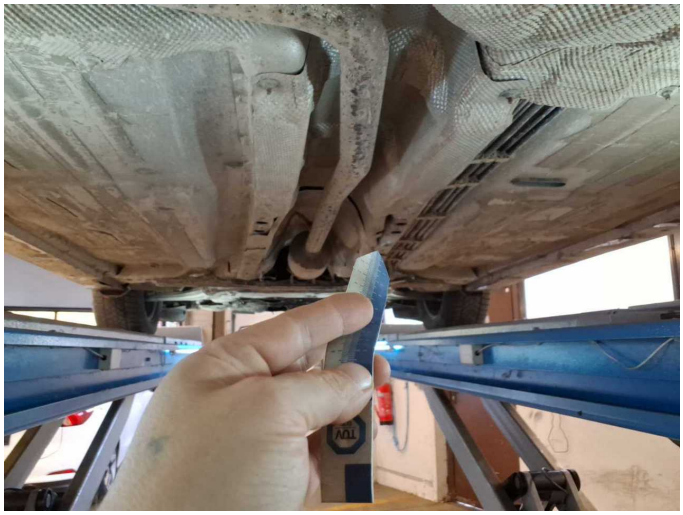
Damage 7: Exhaust system: Heat shield - Broken / torn - Replace

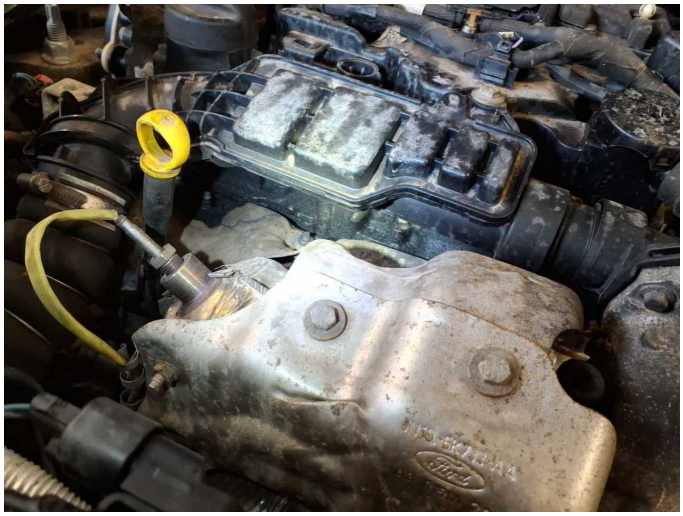
Damage 11: Engine: Engine (Extrem Ölfeucht) - Leaking - Perform diagnosis

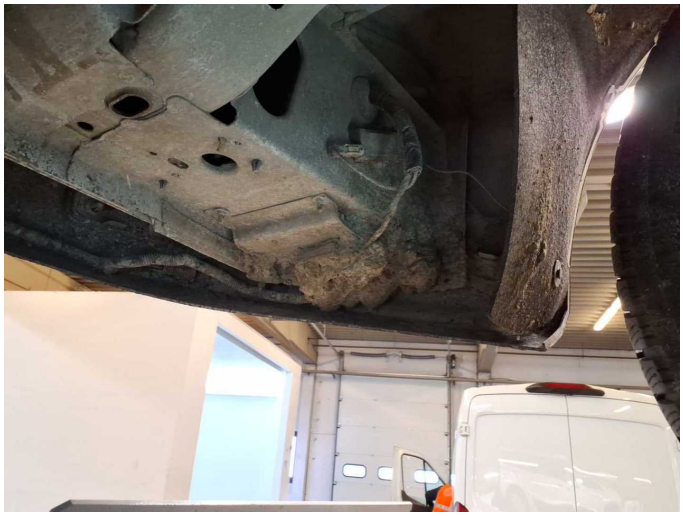
Damage 15: Body: Underbody (Extrem, Beton o.ä) - Soiled - Conditioning

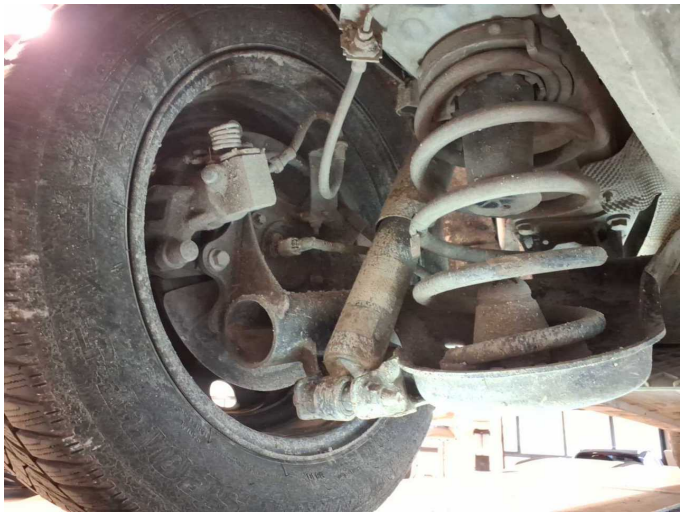
Damage 15: Body: Underbody (Extrem, Beton o.ä) - Soiled - Conditioning

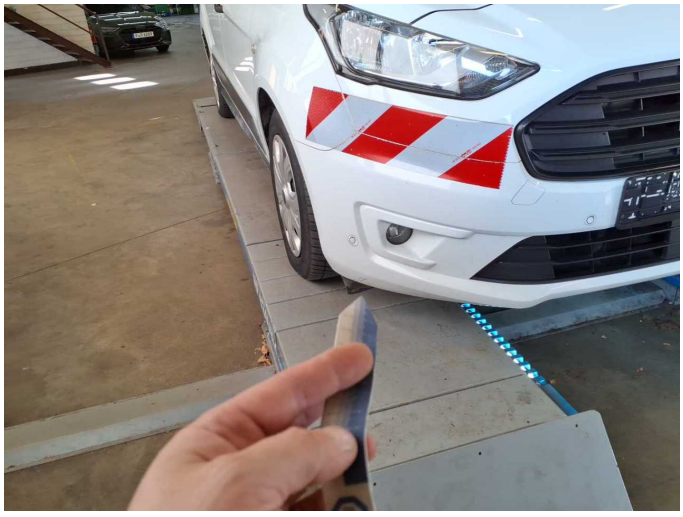
Damage 16: Front bumper: Front bumper (Unterteil) - Scratch(es) - Paint

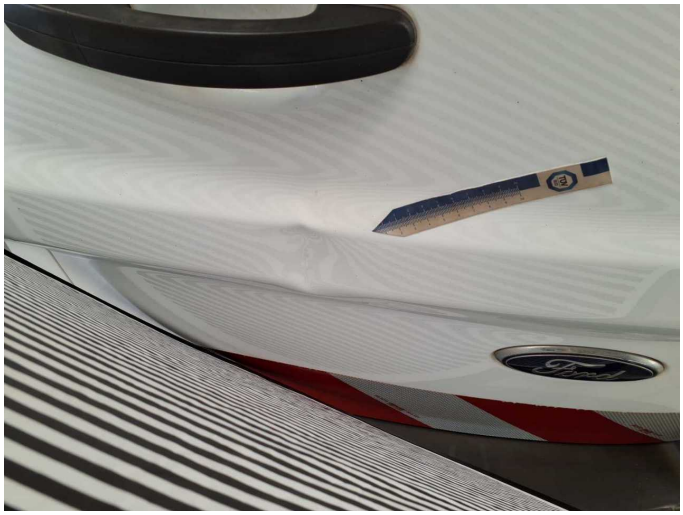
Damage 17: Boot lid / rear door: Rear door - right side - Deformed - Repair and paint
