TÜV SÜD Auto Partner GmbH
Wiesenring 2
04159 Leipzig

Expertise

Protocol number: 48211606
Order No. / Reference: 27151713
Inspection date: 19 Oct 2026

Manufacturer: Skoda	Model: Enyaq iV 60
VIN: TMBJB9NY3PF042042

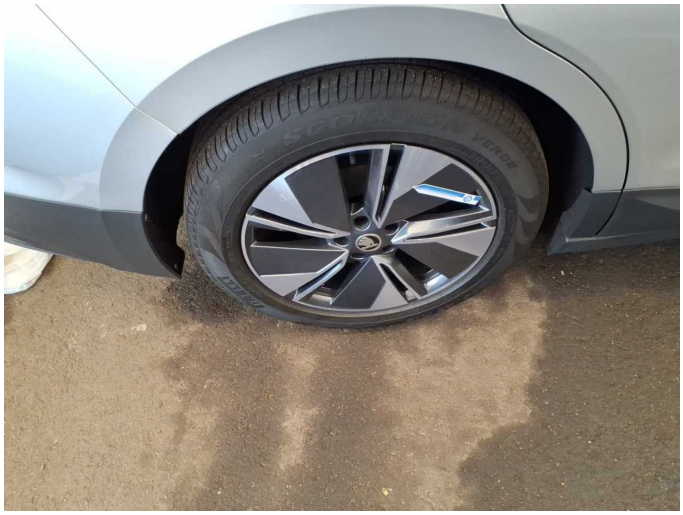
No.	Component group	Description
1	Front bumper	Front bumper - Scratch(es) - Smart repair
2	Wheel / tyres	Alloy rim - rear right side - Scratch(es) - Loss in value

Damage 2: Wheel / tyres: Alloy rim - rear right side - Scratch(es) - Loss in value
