TÜV SÜD Auto Partner GmbH
Wiesenring 2
04159 Leipzig

Expertise

Protocol number: 48213179
Order No. / Reference: 27046467
Inspection date: 19 Oct 2026

Manufacturer: Skoda	Model: Octavia Combi 2.0 TDI DSG Clever
VIN: TMBJJ8NX9PY014903

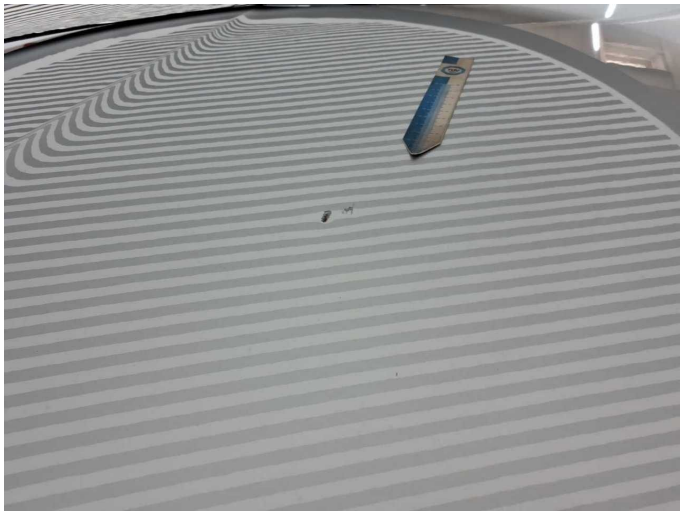
No.	Component group	Description
1	Equipment	Tirefit filler - Expired - Replace
2	Instrument panel	Indicator light (Reifendruck) - on - Perform diagnosis
3	Front bumper	Front bumper (+ viele Steinschläge) - Scratch(es) - Paint
4	Bonnet	Bonnet (+ delle) - Stone chips - Paint

Damage 4: Bonnet: Bonnet (+ delle) - Stone chips - Paint
