Expertise

Protocol number: 48015213
Order No. / Reference: 27044904
Inspection date: 8 Oct 2026

Manufacturer: Ford	Model: Focus Turnier 1.5 EcoBlue Start-Stopp-System Aut. TITANIUM STYLE
VIN: WF0PXXGCHPNT51554

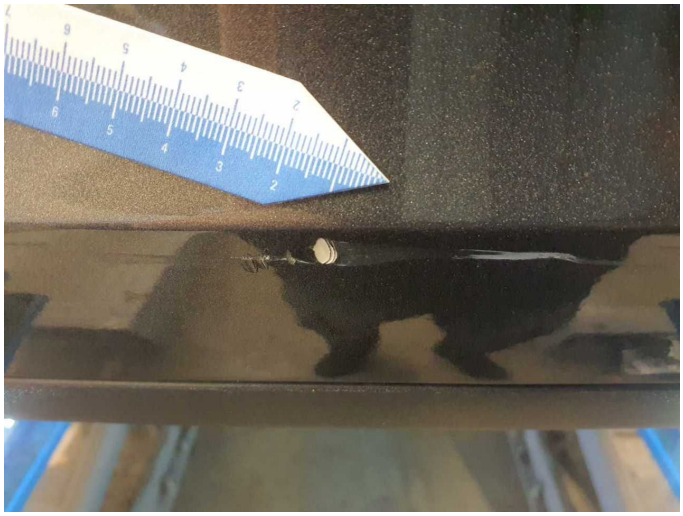
Damage 3: Roof: Roof - dent(s) - Smooth repair work
