Expertise

Protocol number: 48386267
Order No. / Reference: 27175259
Inspection date: 27 Oct 2026

Manufacturer: Mercedes-Benz	Model: Vito 116 CDI Extralang HA BASE
VIN: W1V44760513898033

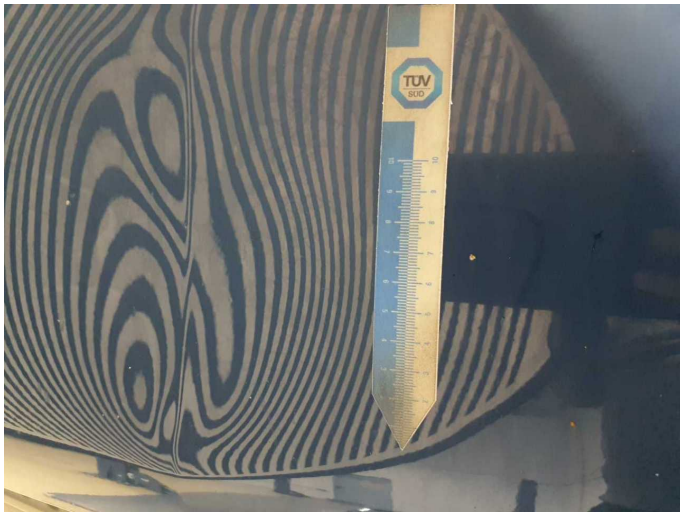
Damage 9: Bonnet: Bonnet - Dent / paintcoat damage - Repair and paint

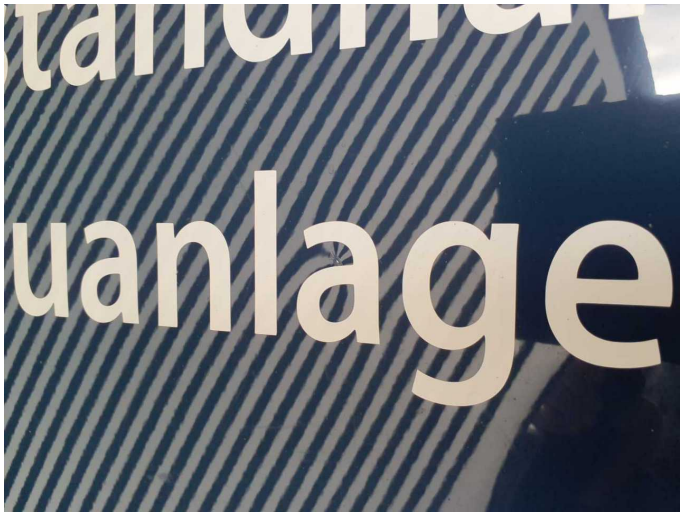
Damage 9: Bonnet: Bonnet - Dent / paintcoat damage - Repair and paint

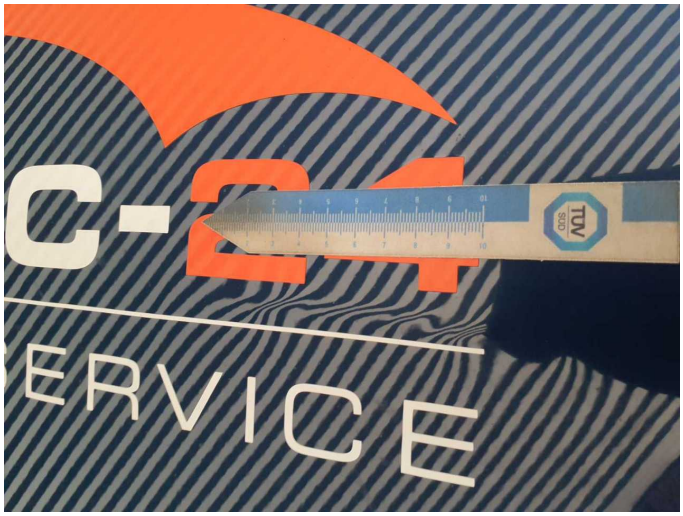
Damage 10: Boot lid / rear door: Boot lid - Deformed - Repair and paint

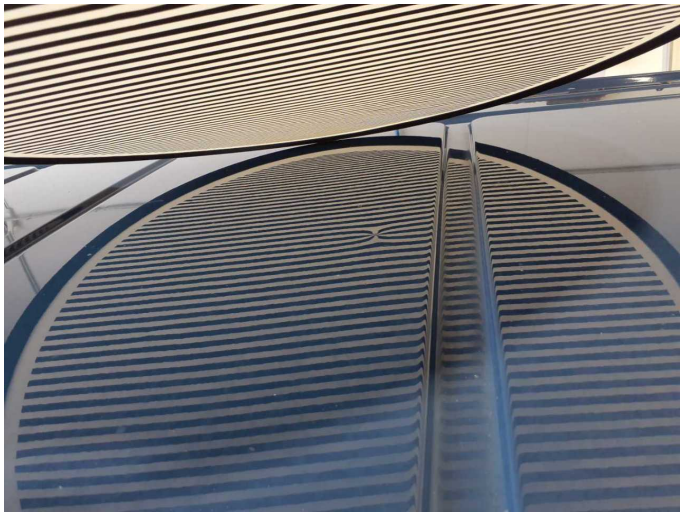
Damage 11: Roof: Roof - dent(s) - Repair and paint

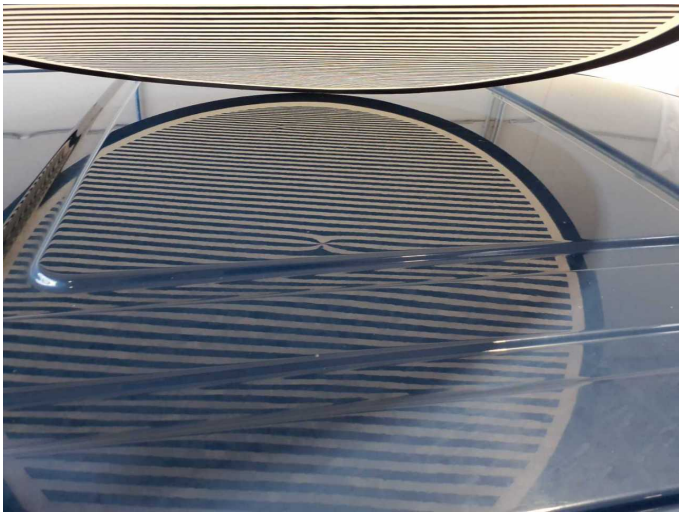
Damage 11: Roof: Roof - dent(s) - Repair and paint
