APPRAISAL REPORT

Make:	VOLKSWAGEN
Model / version:	GOLF VIII
Wine:	WVWZZZCD9PW310901
Plate:	2DUA346
Mileage:	83800
SOH:	
First registration:	26/06/2023
Color:	deep black p

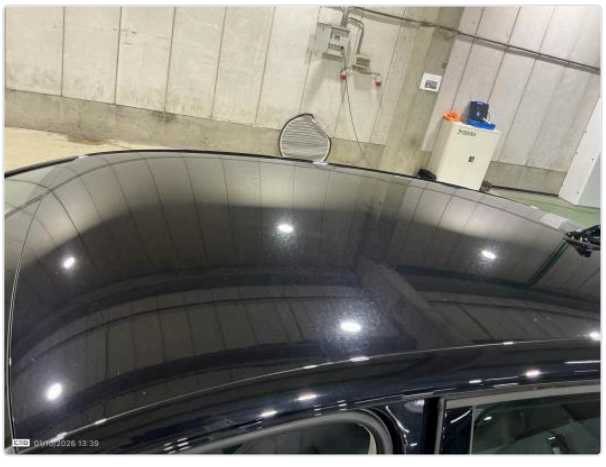
#	Rental	Damage type	Renta®	Repaired	Already invoiced
2	Bodywork	Teeth and scratches	✓	✗	✗

2 - Bodywork - Dent(s) and scratch(es) - Renta®
