Skoda

VIN: TMBJW8NX5PY009571

Estimated repair cost

Registration number
2JBP786

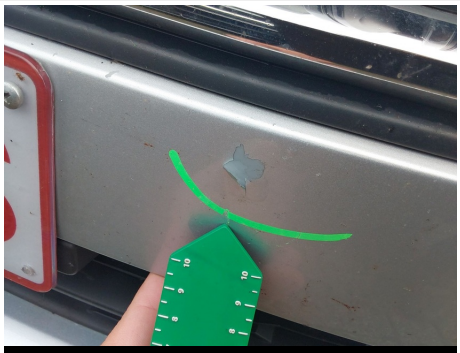
Bumper / Front / Improper Repair

Door / Front Left / Scratched

Rear-view mirror / Left / Scratched

Interior complete / - / Dirty

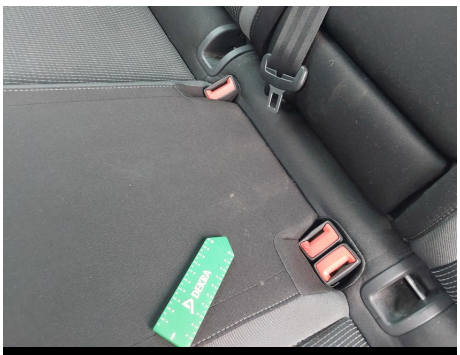
Interior complete / - / Dirty

Fabric door lining / Back Left / Tear

Tailgate / Boot door / - / Scratched

Bumper / Back / Scratched

Interior tailgate lining / Back / Scratched

Fabric door lining / Back Right / Scratched

Roof / - / Scratched
