MACADAM

BMW I4

Vehicle information

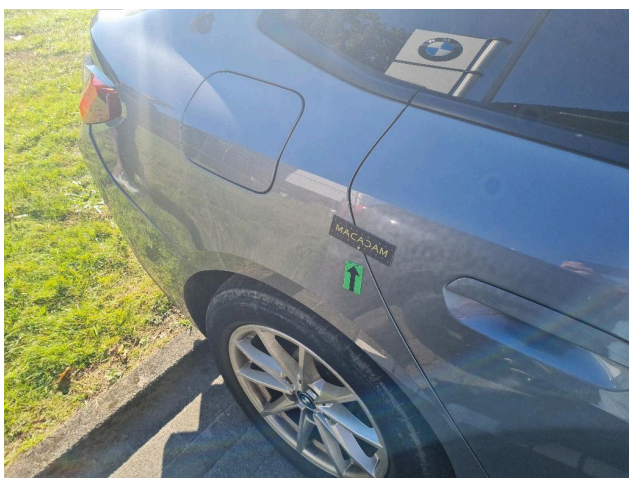
Left Wing
Claw(s)
Paint
Left

Bodywork

Damaged -

Acceptable.

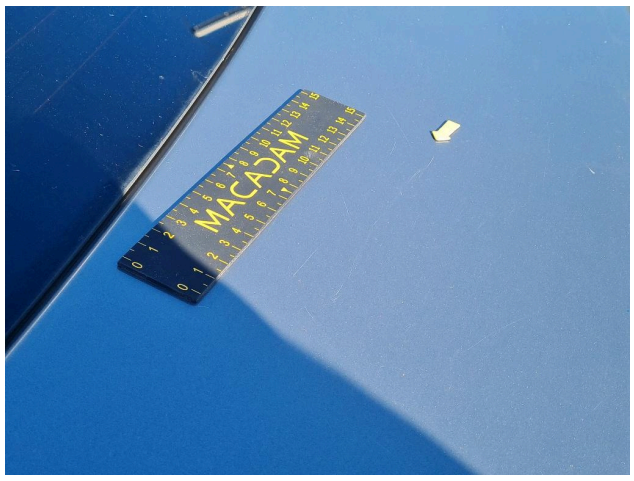
Trunk/Hatchback
Scratch(es)
Paint
Rear

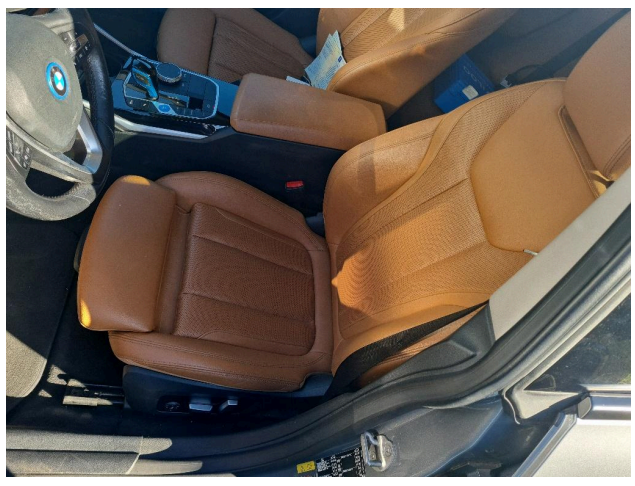
Damaged **Interior**
- Acceptable
Interior
