Expertise

Protocol number: 48415752
Order No. / Reference: 27157721
Inspection date: 28 Oct 2026

Manufacturer: Volkswagen	Model: Touran 2.0 TDI SCR DSG Comfortline
VIN: WVGZZZ1TXPW029423

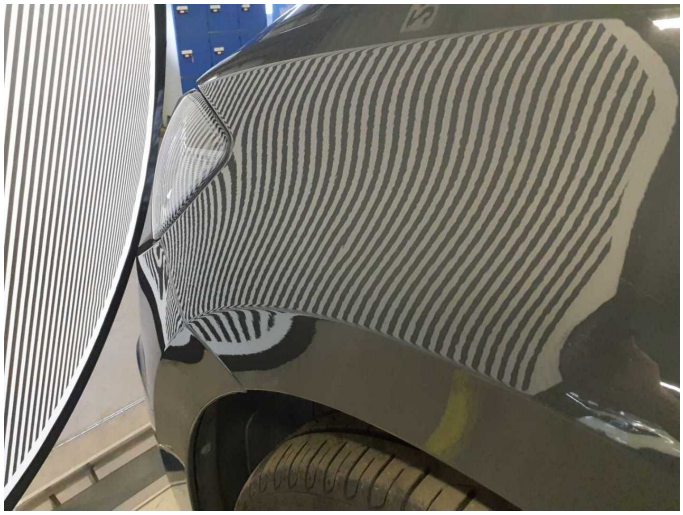
Damage 3: Mudguard - left side: Mudguard - left side - Dent / paintcoat damage - Repair and paint

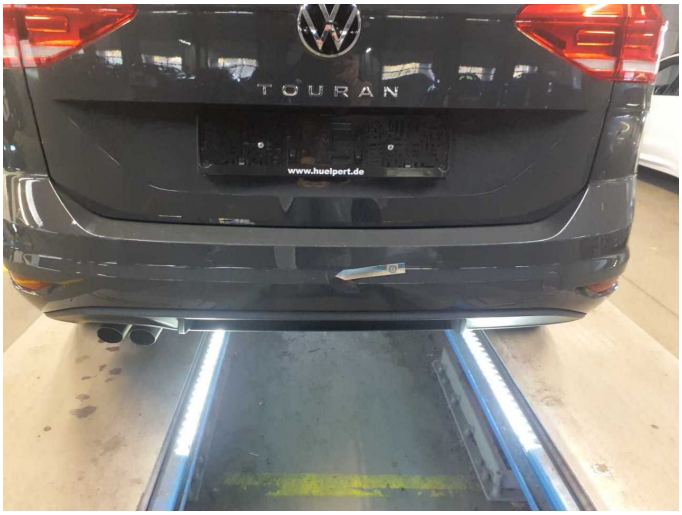
Damage 4: Rear bumper: Rear bumper - Scratched - Paint

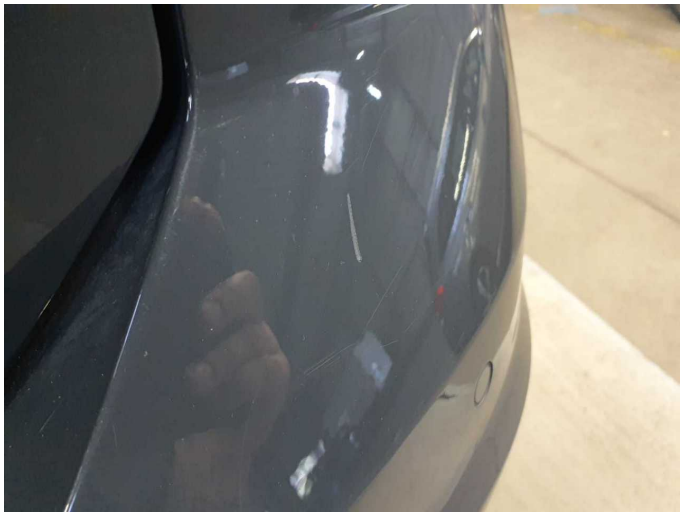
Damage 4: Rear bumper: Rear bumper - Scratched - Paint

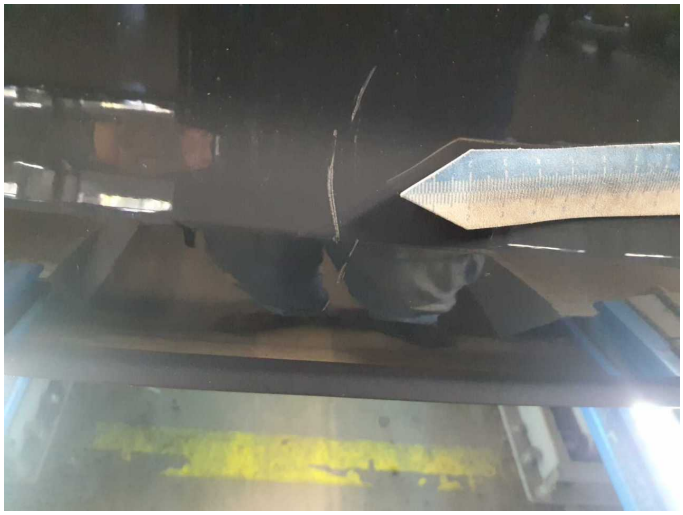
Damage 4: Rear bumper: Rear bumper - Scratched - Paint

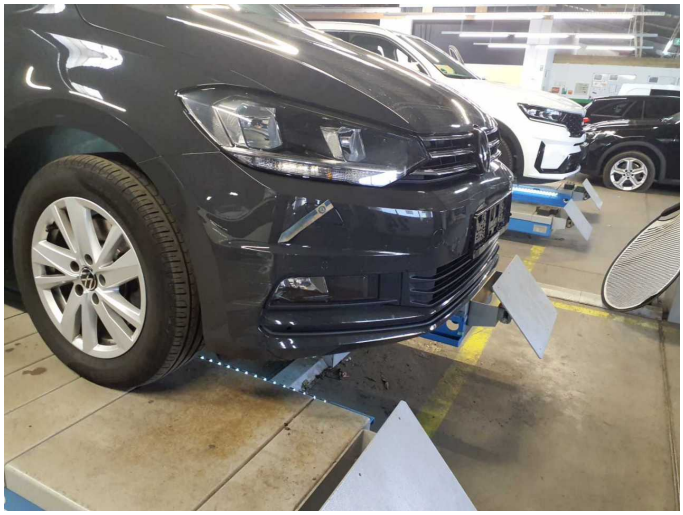
Damage 5: Front bumper: Front bumper - Scratched - Paint

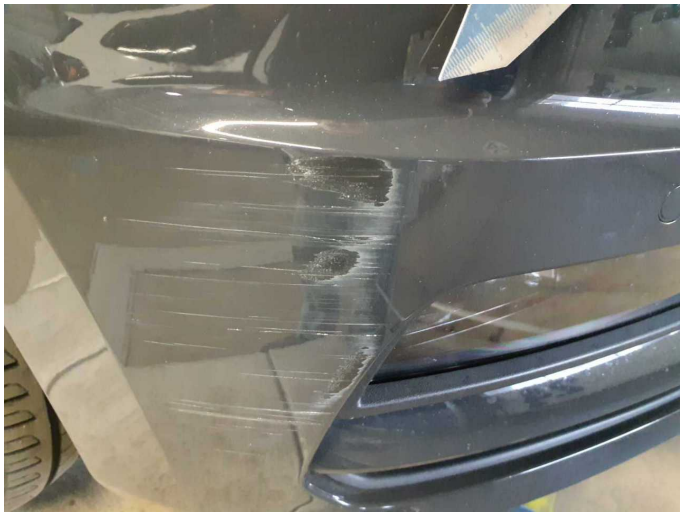
Damage 5: Front bumper: Front bumper - Scratched - Paint

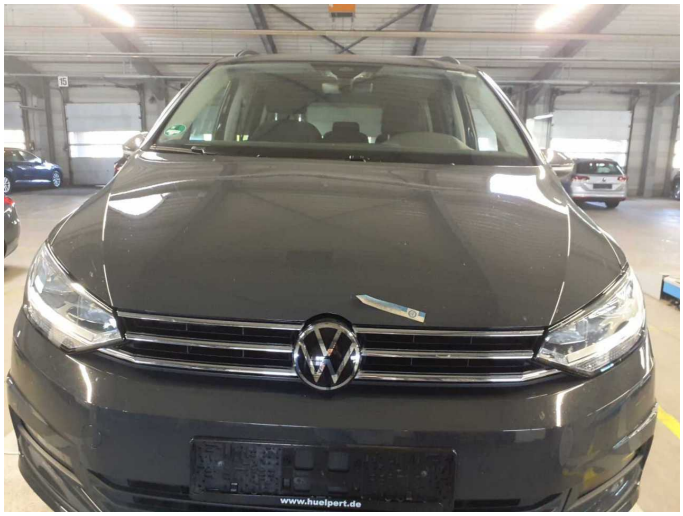
Damage 6: Bonnet: Bonnet - Stone chips - Paint

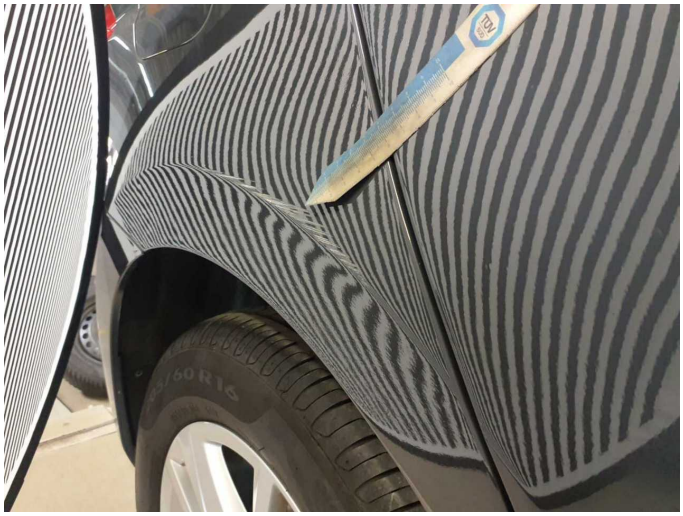
Damage 7: Side panel - rear right side: Side panel - Scratched - Paint

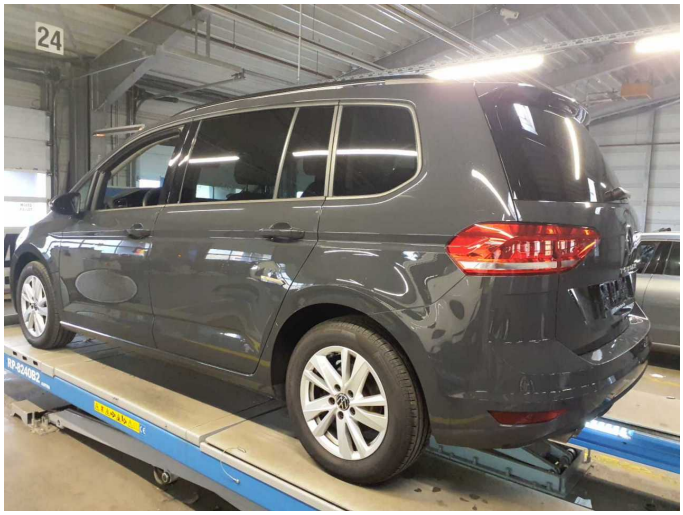
Damage 8: Boot lid / rear door: Boot lid - Deformed - Repair and paint

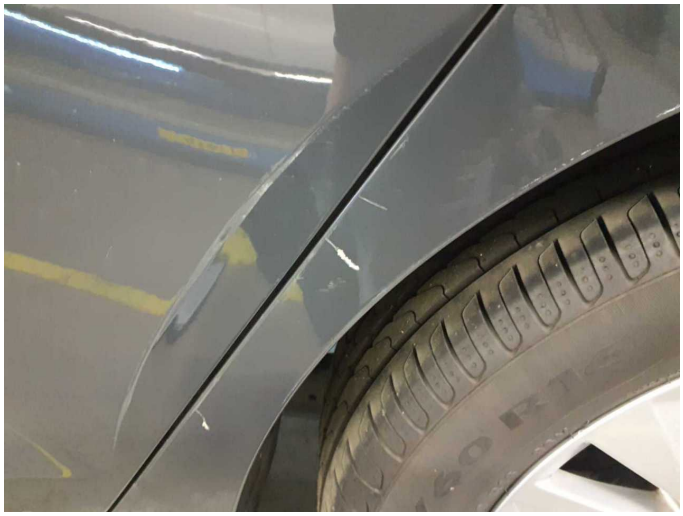
Accident 1: Side - left

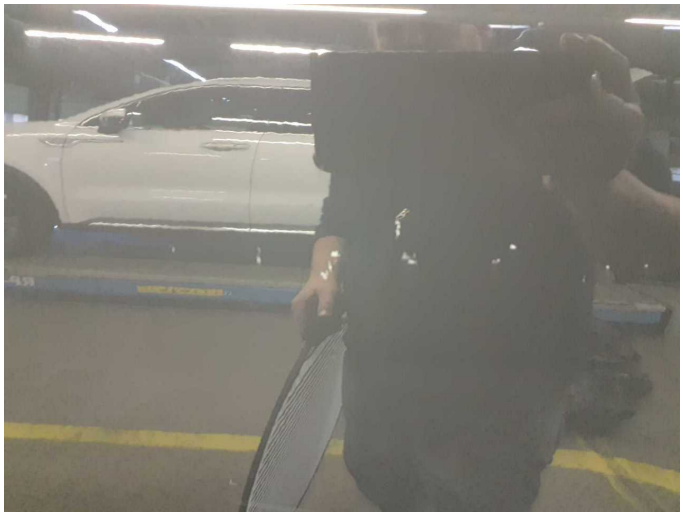
Accident 1: Side - left

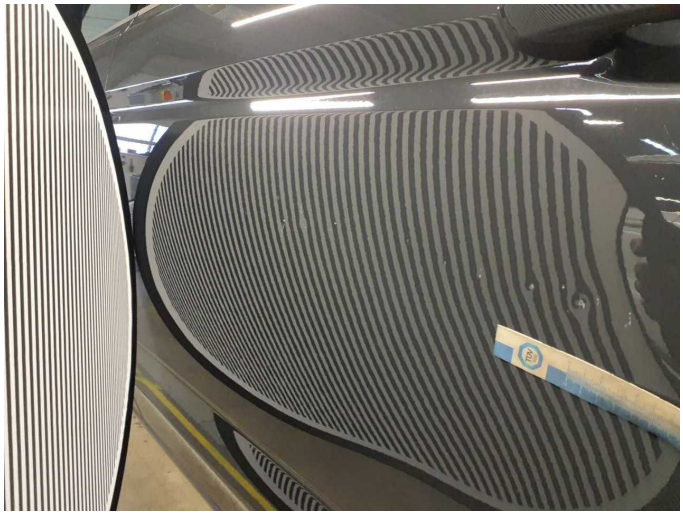
Accident 1: Side - left

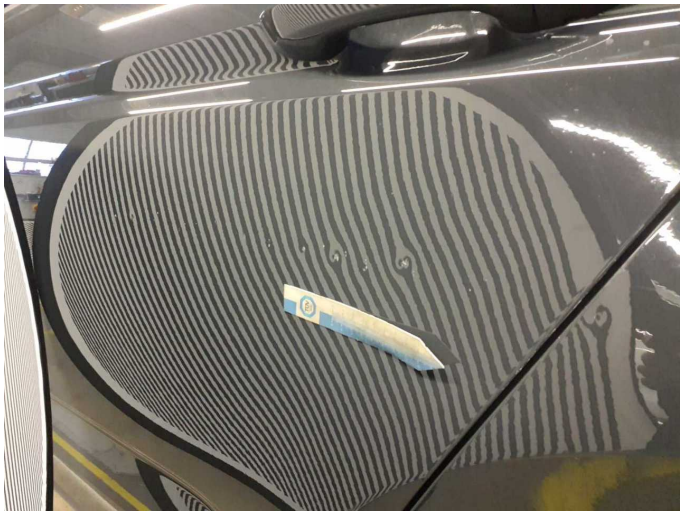
Accident 1: Side - left
