Expertise

Protocol number: 48602211
Order No. / Reference: 27241175
Inspection date: 9 Nov 2026

Manufacturer: Mercedes-Benz	Model: Vito 116 CDI Extralang HA Aut. BASE
VIN: W1V44760513898127

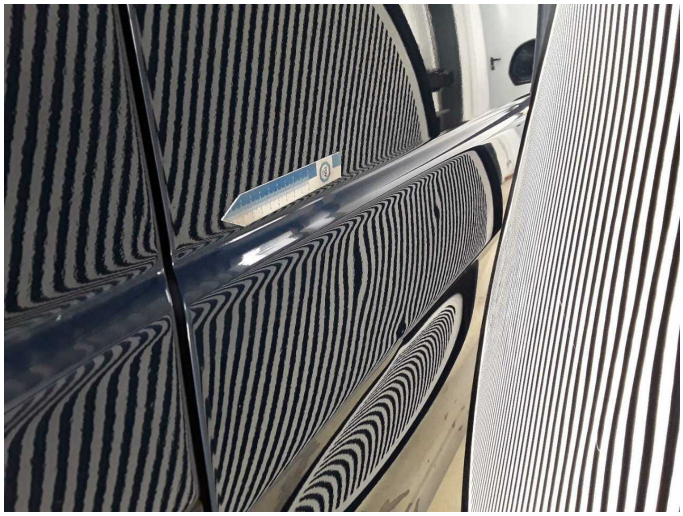
No.	Component group	Description
1	Sliding door, right	Sliding door - Deformed - Smart repair
2	Side panel - rear right side	Side panel - Scratch(es) - Paint
3	Boot lid / rear door	Boot lid - Deformed - Repair and paint
4	Roof	Roof - Deformed - Repair and paint

Damage 1: Sliding door, right: Sliding door - Deformed - Smart repair

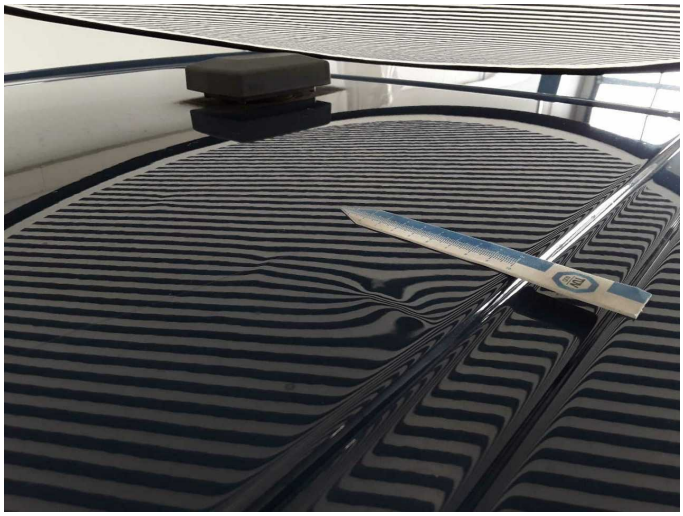
Damage 3: Boot lid / rear door: Boot lid - Deformed - Repair and paint
