Expertise

Protocol number: 47998892
Order No. / Reference: 27150937
Inspection date: 7 Oct 2026

Manufacturer: Mercedes-Benz	Model: C 220 d T 9G-TRONIC AMG Line
VIN: W1KAH0EB0PF114522

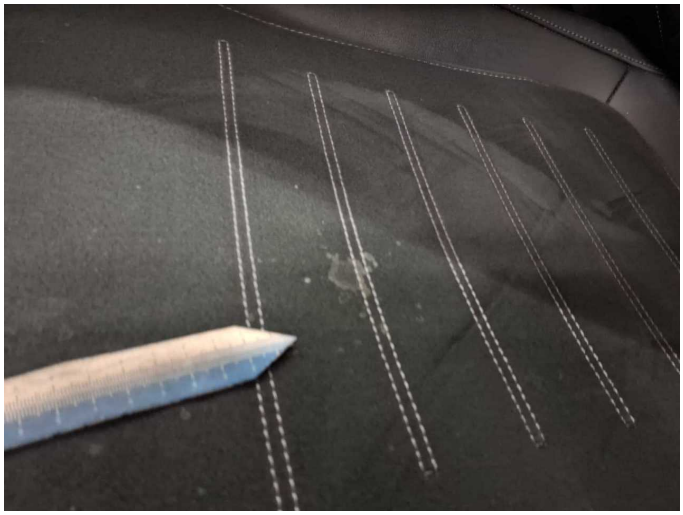
Damage 2: Seat - front: Seat cover - left side - Soiled - Clean

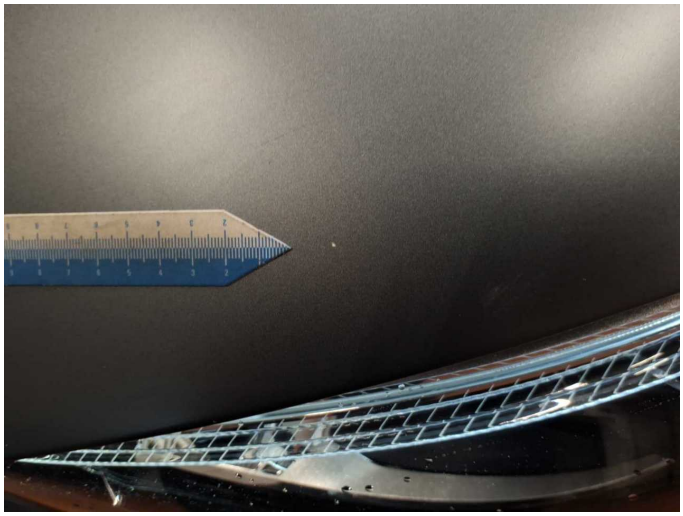
Damage 8: Bonnet: Bonnet - Dent / paintcoat damage - Repair and paint
