MAGADAM

BMW X1

Make:	**BMW**	License:	**2BWJ263**
Gearbox:		Body color:	
Model:	**X1**	VIN:	**WBA71AB0905V31020**
Fuel type:		Power:	**92 kW**
Version:	**1.5 XDRIVE25E PHEV 162KW)**	First registration	**19/04/2022**
Mileage:	**119332 km**	N° of doors:

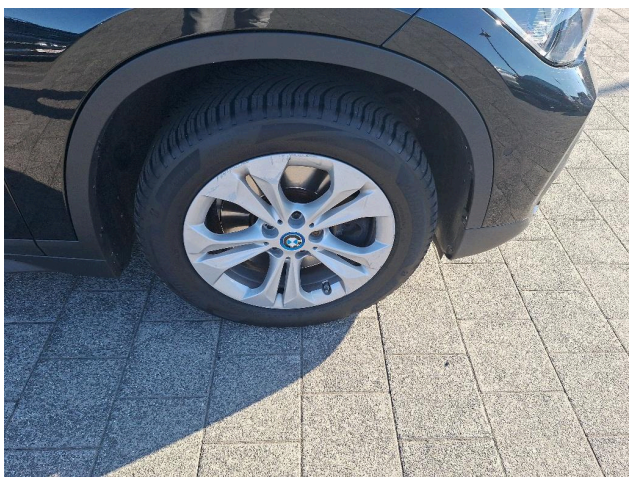
Alloy rim FL
Scratch(es)
Repair and paint (complete)
Left

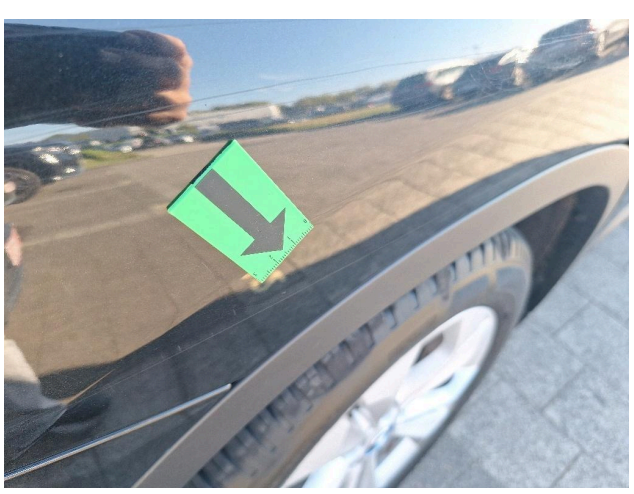
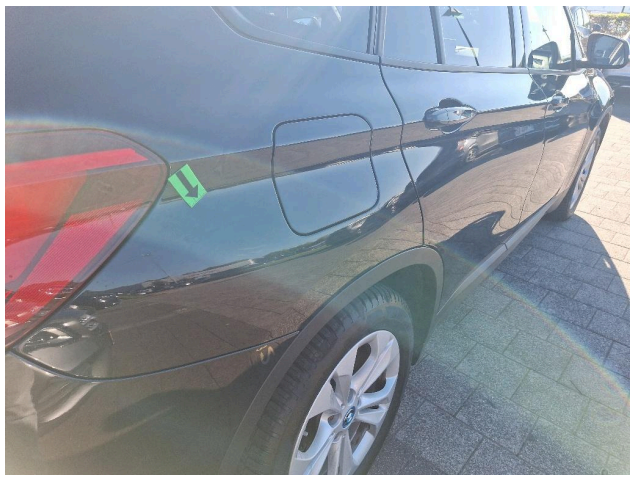
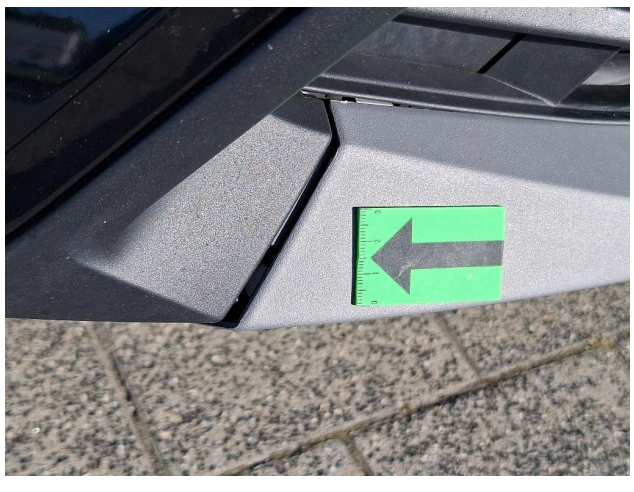
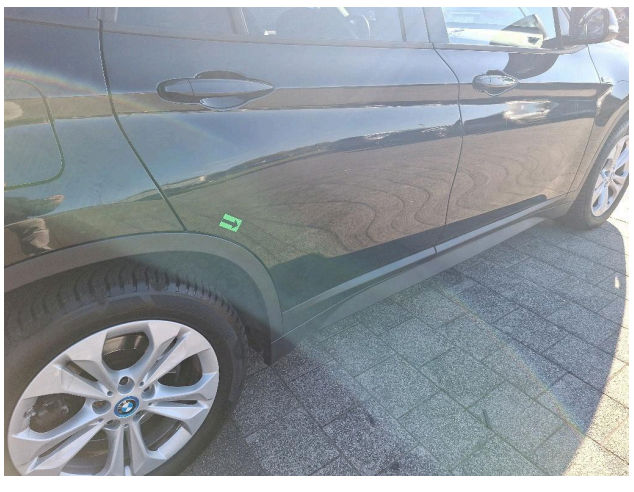
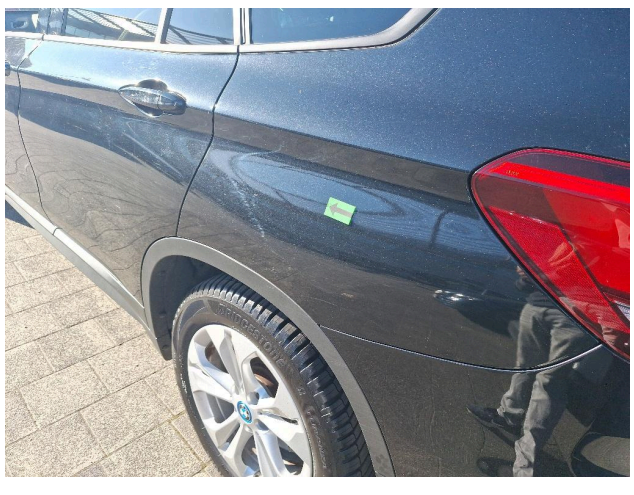
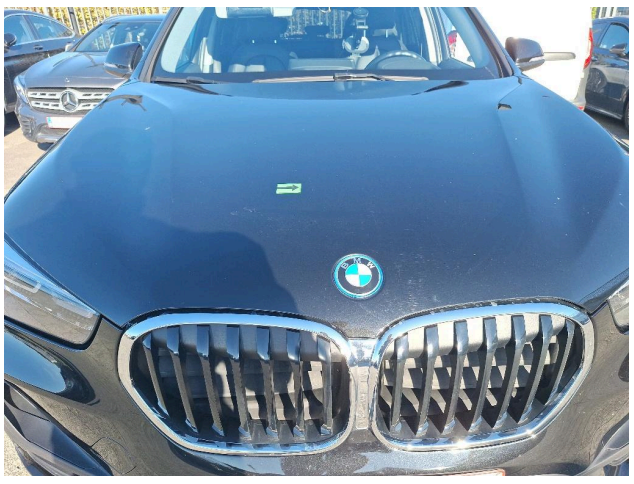
Bodywork
Damaged
Acceptable
Roof & others

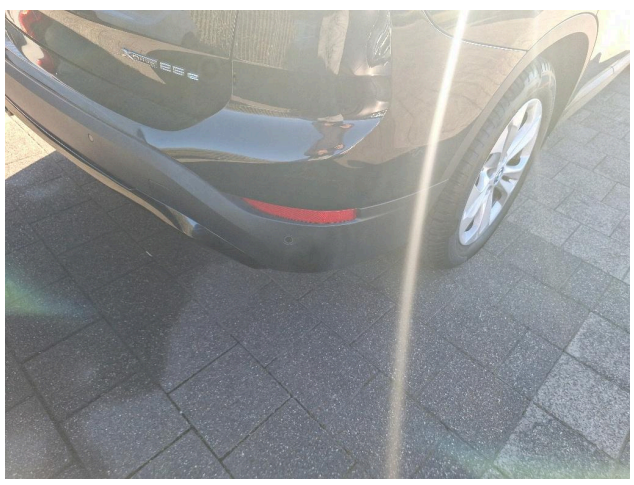
Bumper moulding R
Scratch(es)
Spot repair
Rear
