TÜV SÜD Auto Partner GmbH
Wiesenring 2
04159 Leipzig

# Expertise

Protocol number: 48529419
Order No. / Reference: 27256202
Inspection date: 4 Nov 2026

| Manufacturer: Mercedes-Benz | Model: E 300 e T 9G-TRONIC Exclusive |

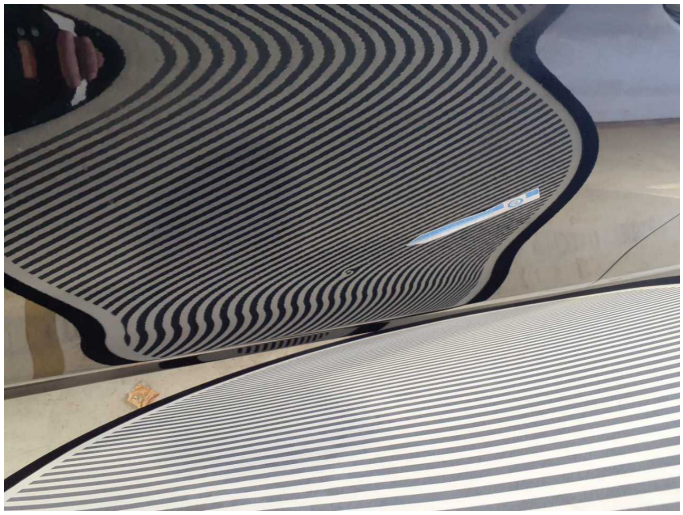
| No. | Component group | Description |
|---|---|---|
| 1 | Door - front left side | Door - dent(s) - Smooth repair work |

**Damage 1:** Door - front left side: Door - dent(s) - Smooth repair work

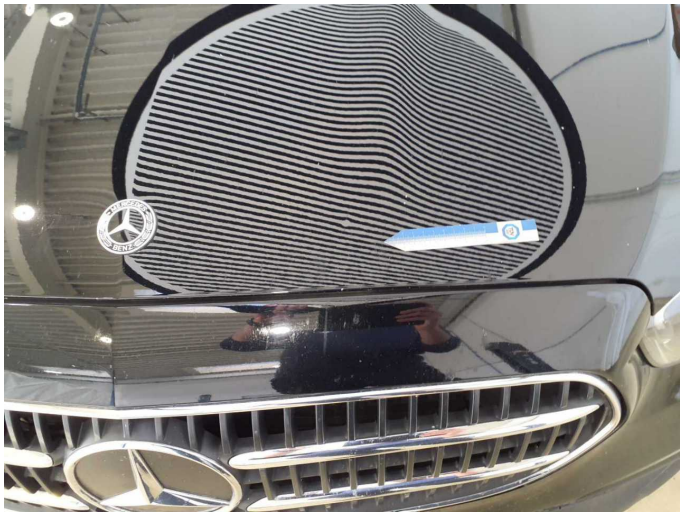
| No. | Component group | Description |
|---|---|---|
| 7 | Bonnet | Bonnet - Dent / paintcoat damage - Loss in value |

**Damage 7:** Bonnet: Bonnet - Dent / paintcoat damage - Loss in value

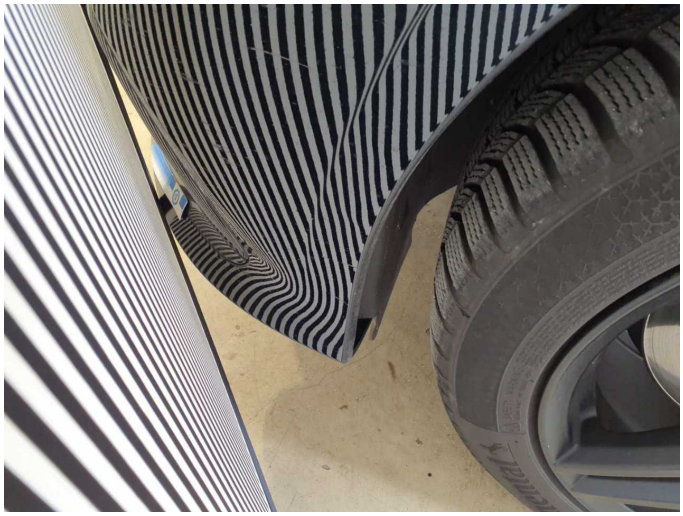
| No. | Component group | Description |
|---|---|---|
| 11 | Front bumper | Front bumper - Dent / paintcoat damage - Repair and paint |

**Damage 11:** Front bumper: Front bumper - Dent / paintcoat damage - Repair and paint

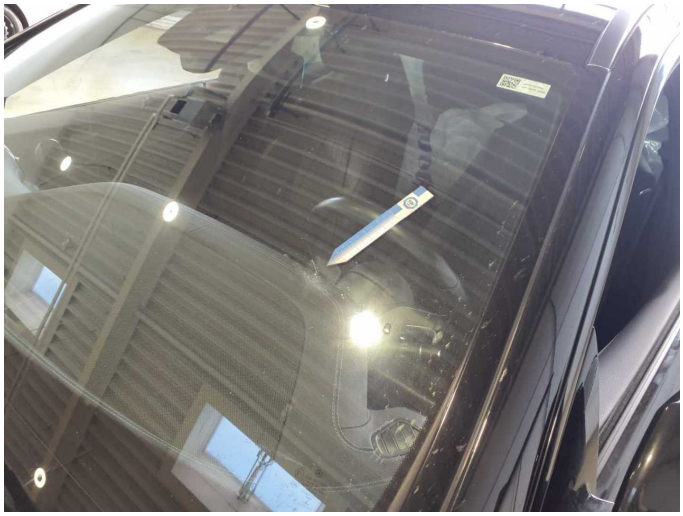
| No. | Component group | Description |
|---|---|---|
| 12 | Vehicle glazing | Windscreen - Stone chips - Replace |

**Damage 12:** Vehicle glazing: Windscreen - Stone chips - Replace

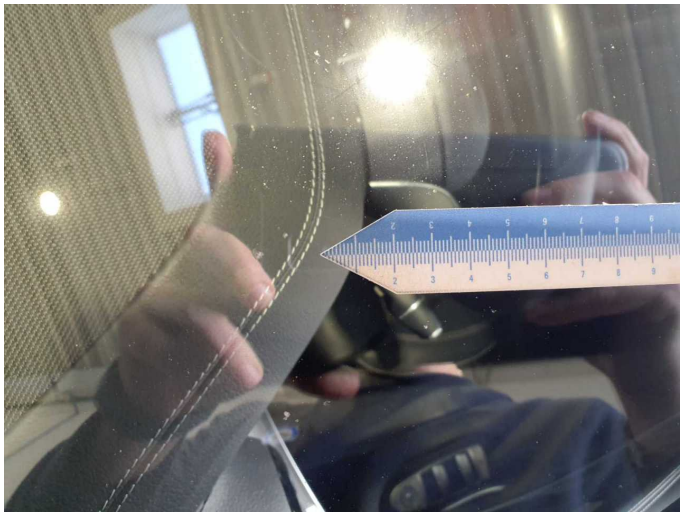
**Damage 12:** Vehicle glazing: Windscreen - Stone chips - Replace

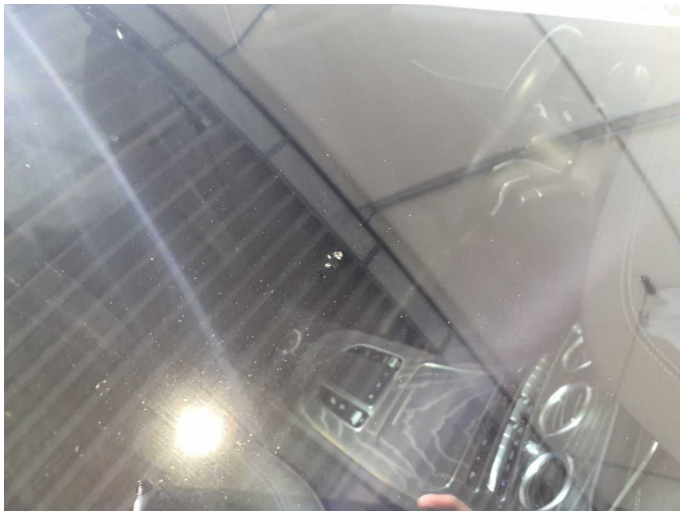
**Damage 12:** Vehicle glazing: Windscreen - Stone chips - Replace
