Expertise

Protocol number: 48242538
Order No. / Reference: 27140561
Inspection date: 20 Oct 2026

Manufacturer: Volkswagen	Model: Passat Variant 2.0 TDI SCR DSG
VIN: WVWZZZ3CZPE025508

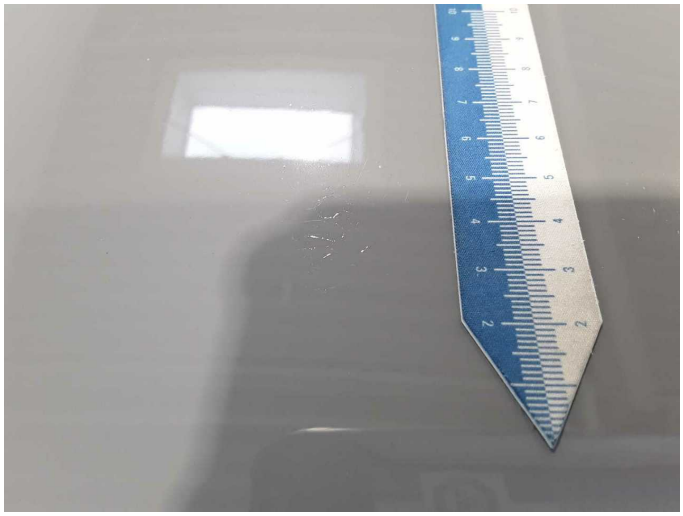
No.	Component group	Description
1	Steering system	Steering wheel - Soiled - Clean
2	Front structure	Emblem - Broken / torn - Replace
3	Front bumper	Front bumper - Scratch(es) - Paint
4	Bonnet	Bonnet (Anätzung) - Paint defect - Repair and paint

Damage 4: Bonnet: Bonnet (Anätzung) - Paint defect - Repair and paint
