MACADAM

Skoda Enyaq '21 BEV

Vehicle information

Damage summary

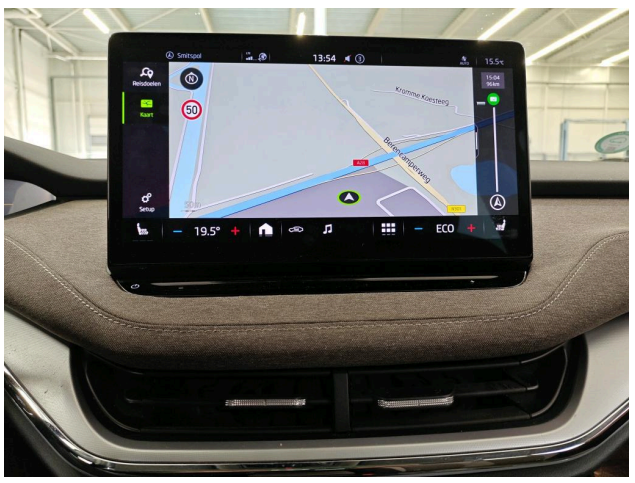
Smitspol
13:56
15.0°
Let op omgeving en klaar om te remmen!
19.5°
Home
Favorieten
Menu
ECO
