Expertise

Protocol number: 48505860
Order No. / Reference: 27242283
Inspection date: 3 Nov 2026

Manufacturer: Volkswagen	Model: Passat Variant 2.0 TDI SCR DSG Business
VIN: WVWZZZ3C2RE008379

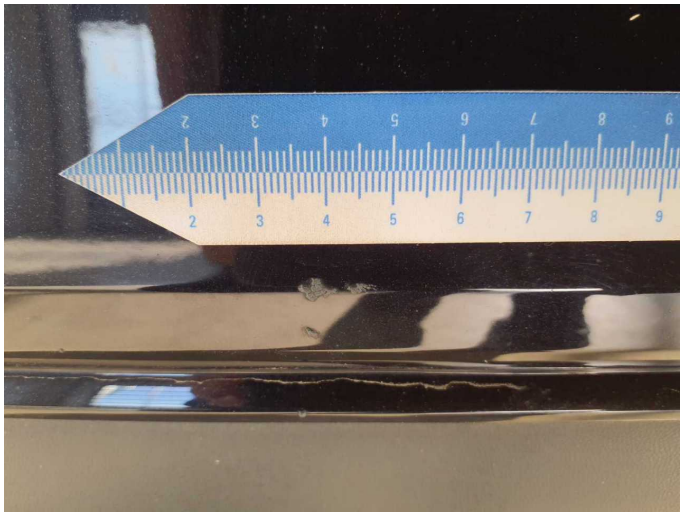
Damage 1: Rear bumper: Rear bumper - Scratch(es) - Smart repair

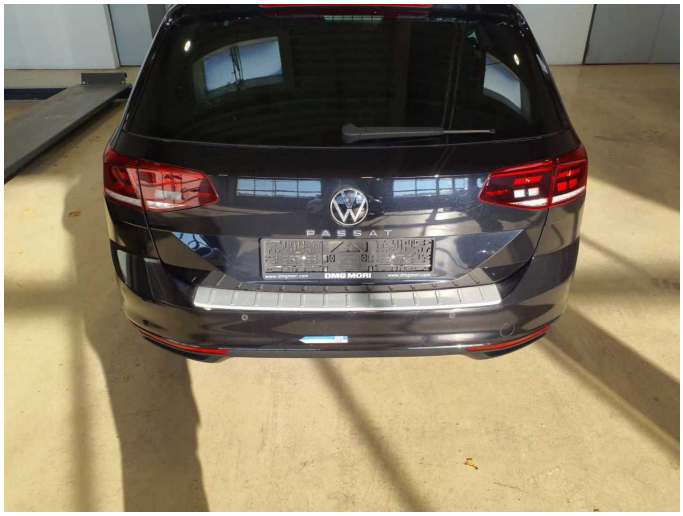
Damage 1: Rear bumper: Rear bumper - Scratch(es) - Smart repair
