Expertise

Protocol number: 48513710
Order No. / Reference: 27238567
Inspection date: 5 Nov 2026

Manufacturer: Volkswagen	Model: Passat Variant 2.0 TDI SCR DSG Conceptline
VIN: WVWZZZ3CZPE009528

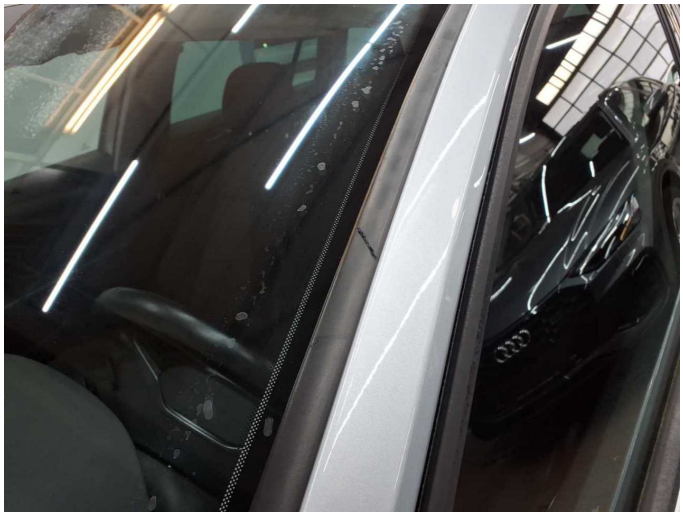
Damage 1: Vehicle glazing: Windscreen (Zierleiste links) - Scratch(es) - Replace
