Expertise

Protocol number: 48423423
Order No. / Reference: 27144276
Inspection date: 27 Oct 2026

Manufacturer: Mercedes-Benz	Model: Vito 116 CDI 4MATIC Mixto Lang Aut.
VIN: W1V44770313907321

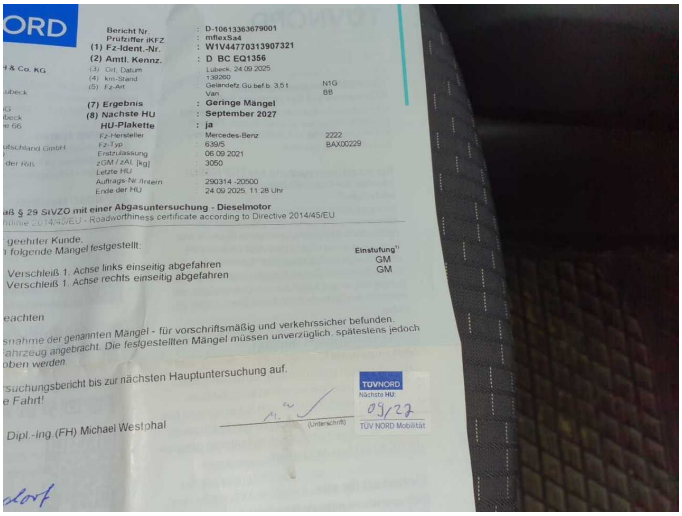
Figure 13: Documents

Maintenance booklet / proof	digital proof / complete	**Next maintenance in**	610 Tag(e)
Last service on / at	06/2026 at 216,129 km		
Key is / should be	2 / 2	**FZG documents**	ZB#2 (B) was available (copy), ZB#1 (S) was not available.
		Letter No.	GE473562
Previous damage / Accident	Detectable	**Repainting**	Detectable
Inspection conditions	Conditional: Light/moisture/dirt	**Lifting equipment / pit**	No
Test drive	Not performed	**Engine function test**	Not possible
readiness to drive	Not roadworthy / not moveable		
Roadworthiness	not roadworthy/operational		
Manufacturer key number/ type code number	2222 / BAX 00229		
Emission standard	EURO6	**fine dust sticker**	
Permitted total weight	2,800 kg	**Empty weight**

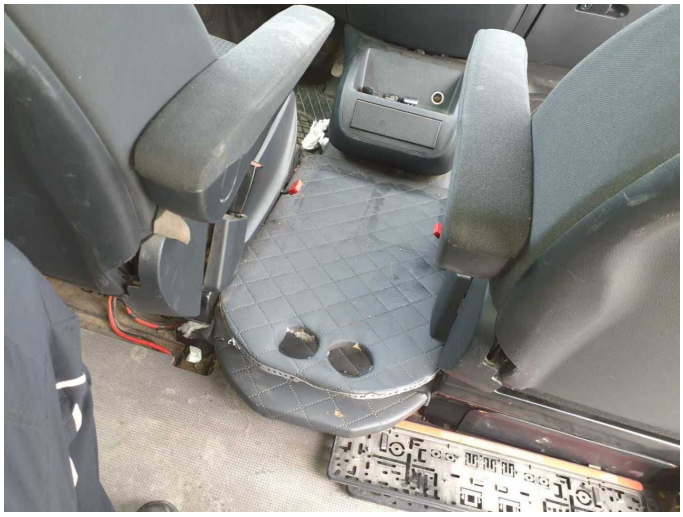
Damage 1: Interior: Interior (Ablage Mitte) - Differs from the original configuration - Un- / install

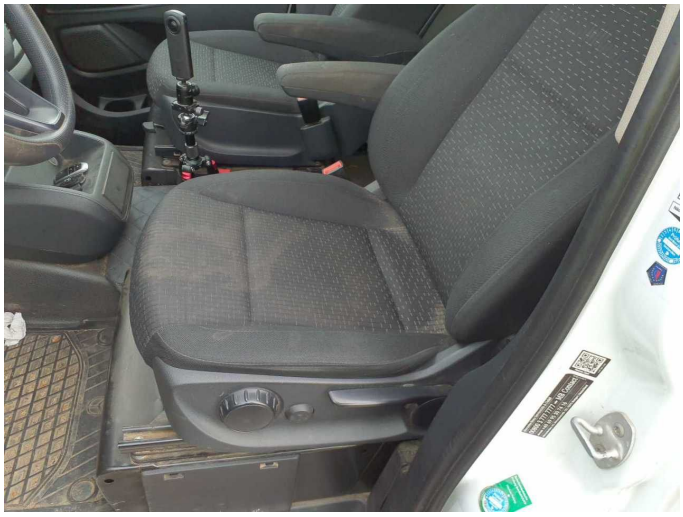
Damage 2: Seat - front: Seat cover - left side (Sitze) - Soiled - Clean

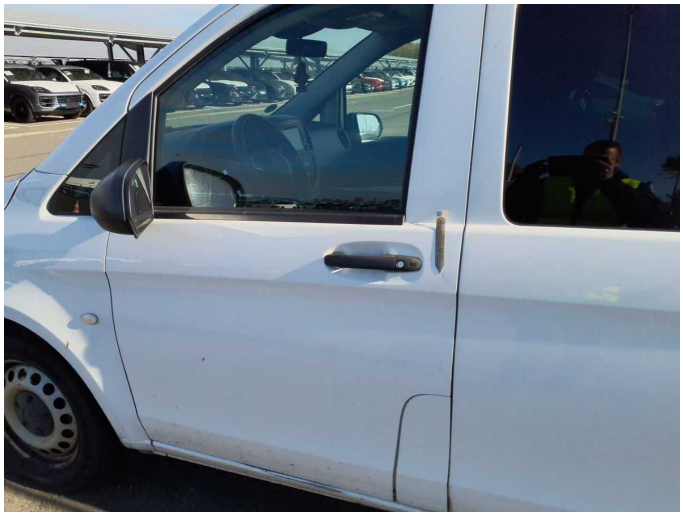
Damage 4: Door - front left side: Door - Scratch(es) - Smart repair

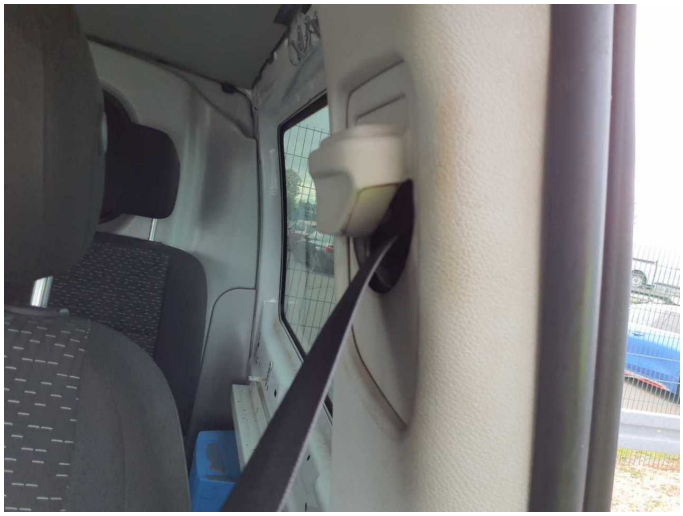
Damage 7: Seat belts - front: Seat belt - front left side (Gurtrollo ohne Funktion) - Non-operational - Replace

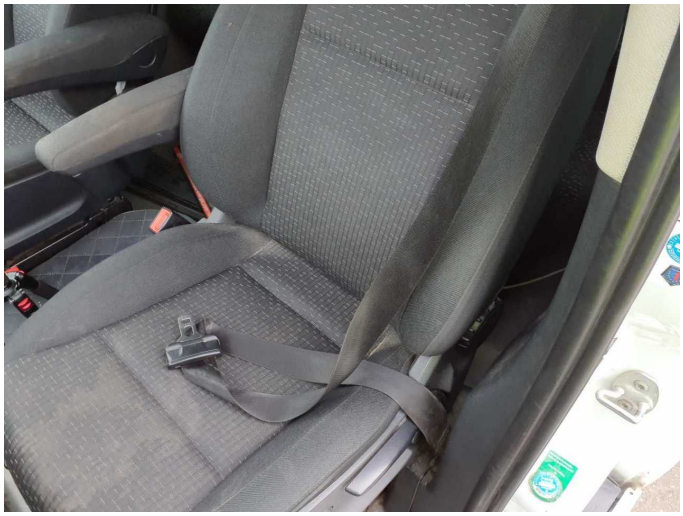
Damage 7: Seat belts - front: Seat belt - front left side (Gurtrollo ohne Funktion) - Non-operational - Replace

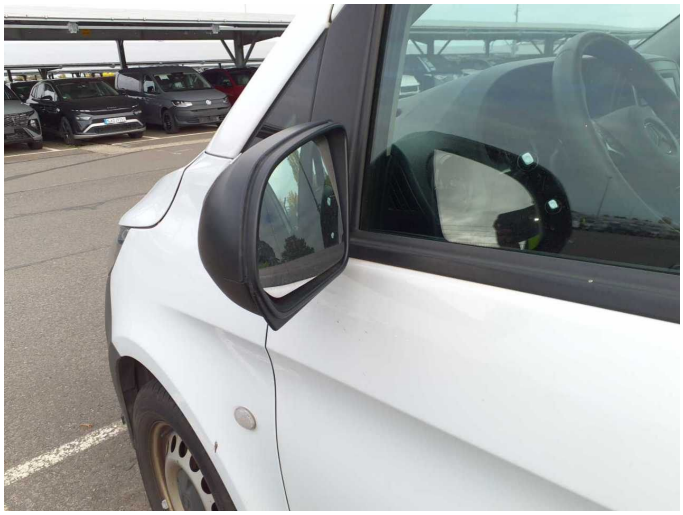
Damage 8: Wing mirror - left side: Mirror housing - Broken / torn - Replace

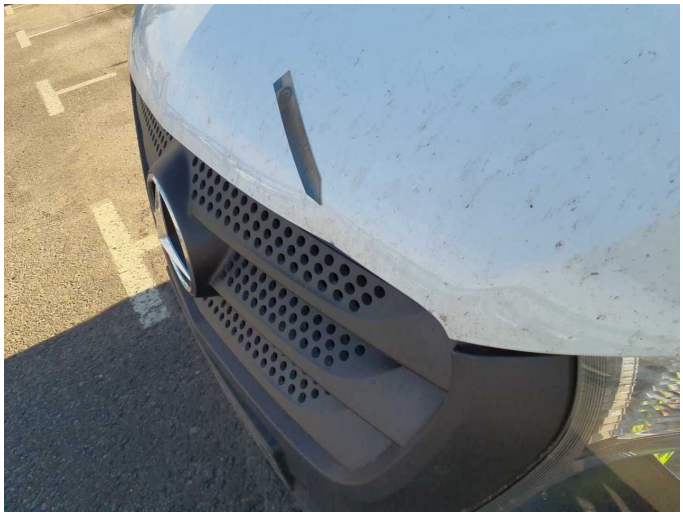
Damage 9: Bonnet: Bonnet - Deformed - Repair and paint

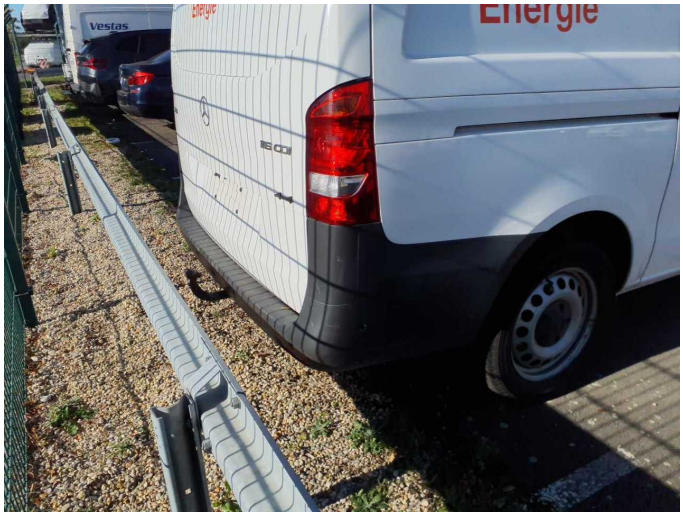
Documents submitted	At the time of the inspection, the vehicle registration certificate Part 2 (title) was available, but the vehicle registration certificate Part 1 (document) was not. (Copy)
VIN comparison	The vehicle identification number (VIN) was read from the vehicle and its conformity with the submitted documents was confirmed by the undersigned during the inspection.
Inspection	A proper visual inspection of the paintwork and bodywork was only possible to a limited extent due to insufficient lighting conditions/dampness or dirt. No lifting equipment or pit was available for inspecting the vehicle. Therefore, inspection of the vehicle's underside was only possible to a limited extent.
Test drive	No test drive/shunting maneuver was carried out during the inspection of the vehicle.
Engine function test	An engine test run could not be performed. This is due to the following reason.: Getriebeschaden

readiness to drive	The vehicle was not roadworthy at the time of inspection, but only capable of being towed.
Roadworthy/operationally safe	Due to the damage characteristic listed under accident or value-reducing factors, the vehicle was not roadworthy or safe to operate at the time of inspection.

Damage 11: Gearbox: Gearbox (siehe KV) - Non-operational - Replace
