MACADAM

TESLA MODEL Y

Vehicle information

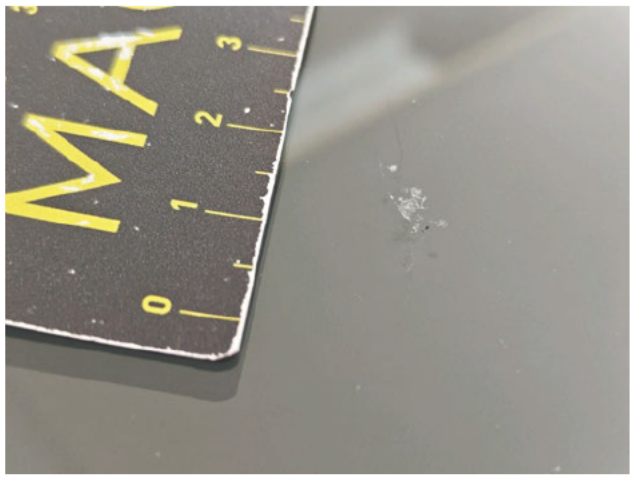
Door RL
Scratch(es)
Repair and paint (partial)
Left
