Expertise

Protocol number: 48443415
Order No. / Reference: 27124774
Inspection date: 2 Nov 2026

Manufacturer: Mercedes-Benz	Model: EQA 250+
VIN: W1N9N0CB0SJ133319

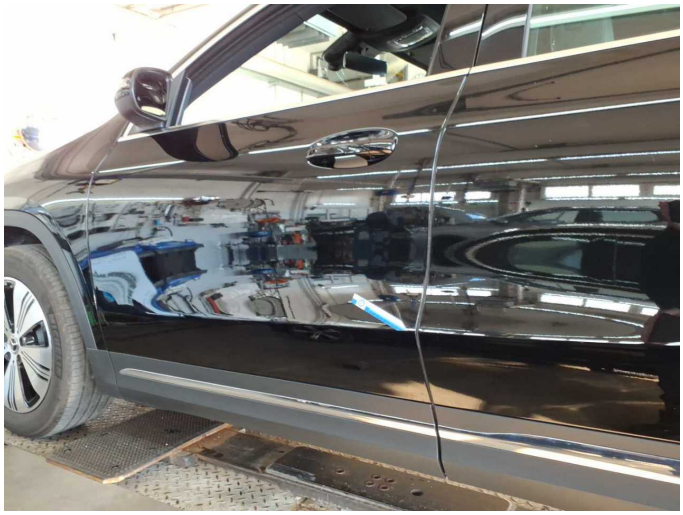
Damage 1: Side panel - rear right side: Side panel - dent(s) - Smooth repair work
