Expertise

Protocol number: 48515265
Order No. / Reference: 27236500
Inspection date: 3 Nov 2026

Manufacturer: Ford	Model: Grand Tourneo Connect 1.5 EcoBlue Start/Stop Trend
VIN: WF0UXXWPGUMP17247

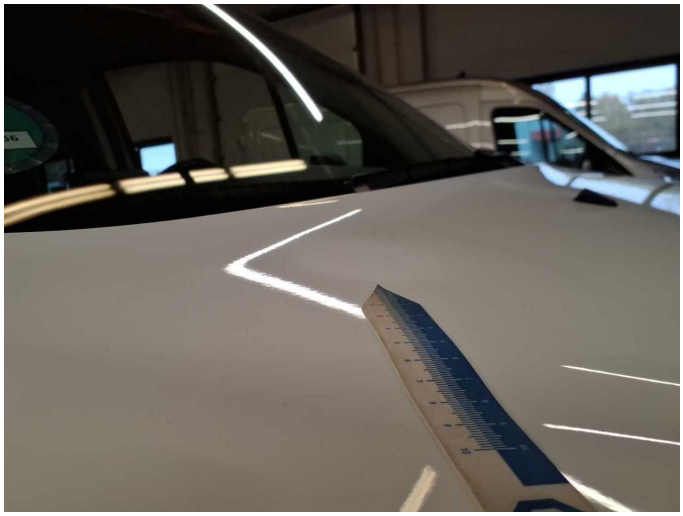
Damage 11: Bonnet: Bonnet (Rostansatz) - Scratch(es) - Repair and paint
