Expertise

Protocol number: 48341254
Order No. / Reference: 27142923
Inspection date: 27 Oct 2026

Manufacturer: Volkswagen	Model: Tiguan Allspace 2.0 TDI SCR DSG Life
VIN: WVGZZZ5N5PM048730

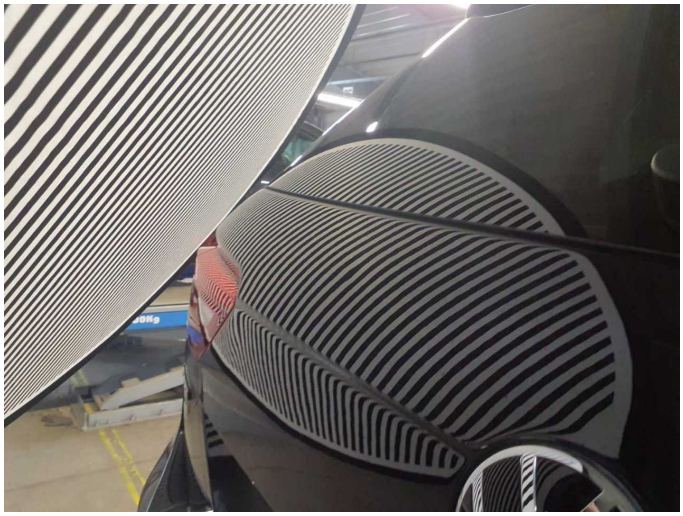
No.	Component group	Description
1	Trim / covers	Floor mats - Holes - Replace
2	Boot lid / rear door	Boot lid - dent(s) - Smooth repair work
3	Rear bumper	Rear bumper - Scratched - Paint
4	Bonnet	Bonnet - Deformed - Repair and paint

Damage 2: Boot lid / rear door: Boot lid - dent(s) - Smooth repair work

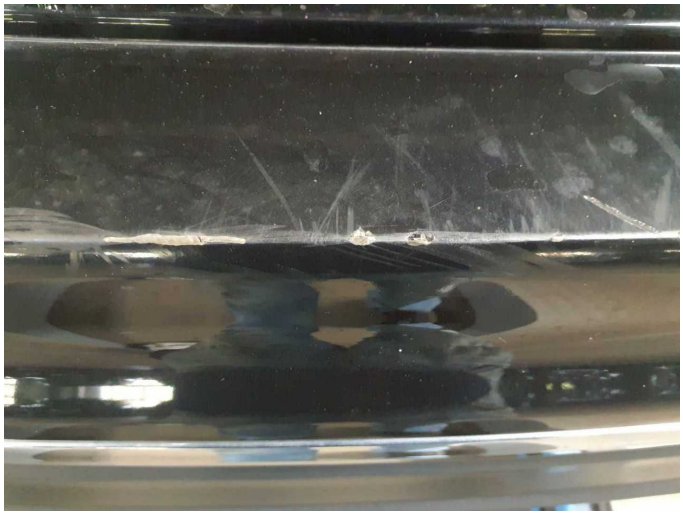
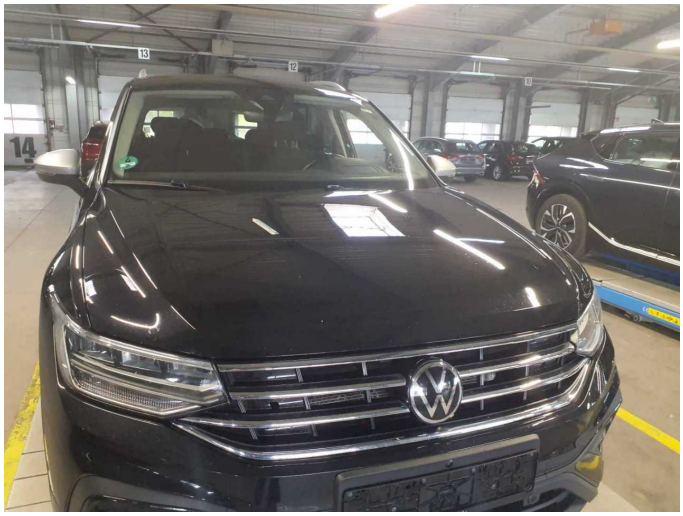
Damage 3: Rear bumper: Rear bumper - Scratched - Paint

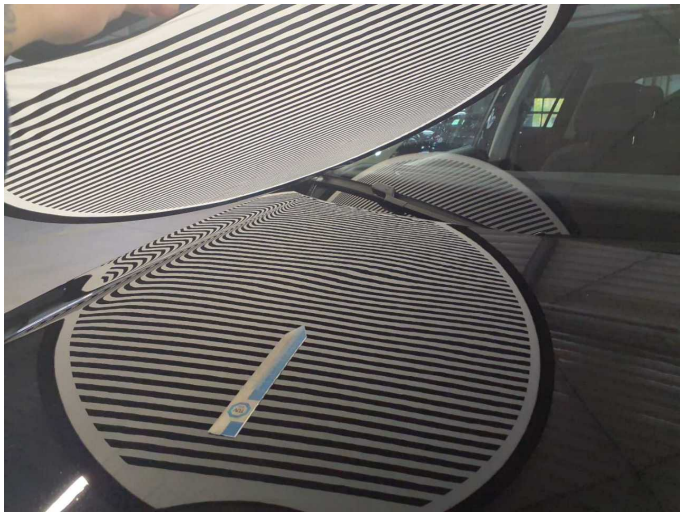
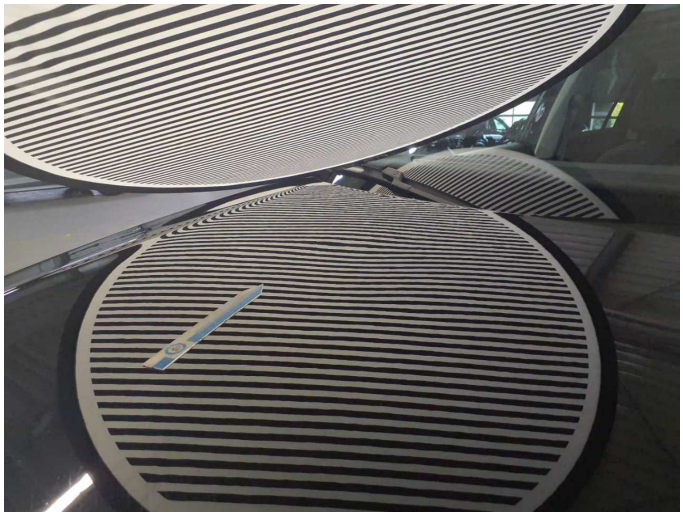
Damage 4: Bonnet: Bonnet - Deformed - Repair and paint
