TÜV SÜD Auto Partner GmbH
Wiesenring 2
04159 Leipzig

Expertise

Protocol number: 47736020
Order No. / Reference: 27026545
Inspection date: 23 Sept 2026

Manufacturer: Audi	Model: S6 Avant TDI quattro tiptronic
VIN: WAUZZZF20RN015685

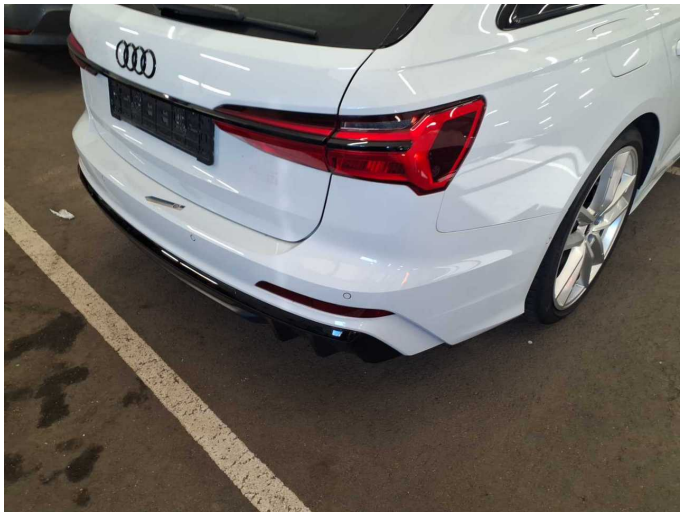
Damage 1: Rear bumper: Rear bumper - Scratch(es) - Smart repair

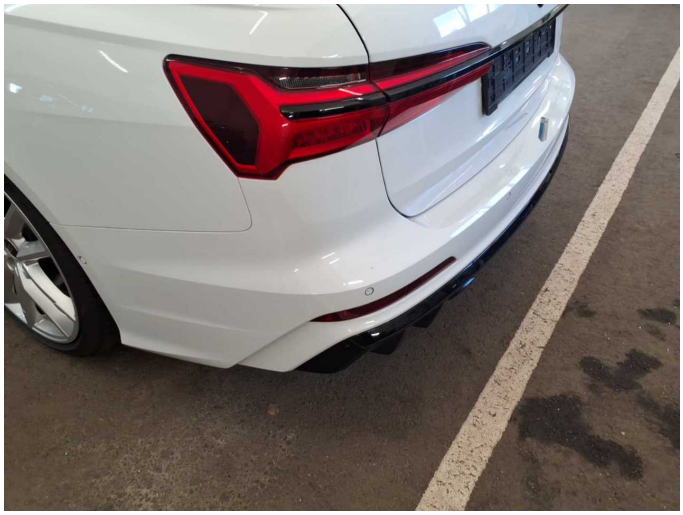
Damage 1: Rear bumper: Rear bumper - Scratch(es) - Smart repair
