Expertise

Protocol number: 48350912
Order No. / Reference: 27013365-1
Inspection date: 7 Oct 2026

Manufacturer: Opel	Model: Astra Sports Tourer 1.5 D Business Edition
VIN: VXKFCYHZLP1052748

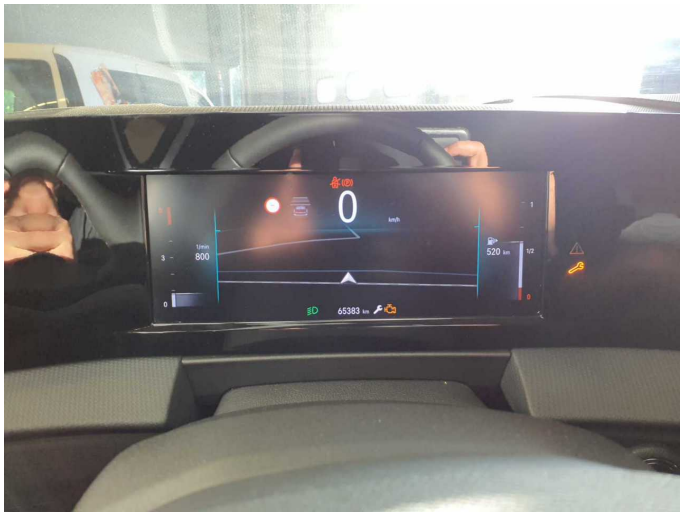
Figure 7: Instrument cluster

Damage 5: Instrument panel: Indicator light - on - Perform diagnosis

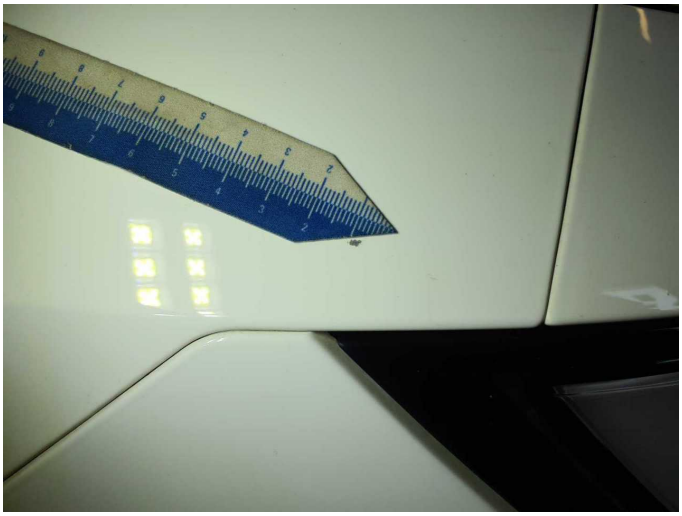
Damage 1: Mudguard - right side: Mudguard - right side - Stone chips - Smart repair
