Expertise

Protocol number: 48504000
Order No. / Reference: 27235492
Inspection date: 2 Nov 2026

Manufacturer: Audi	Model: Q4 e-tron 50 Sportback quattro
VIN: WAUZZZFZ6RP006880

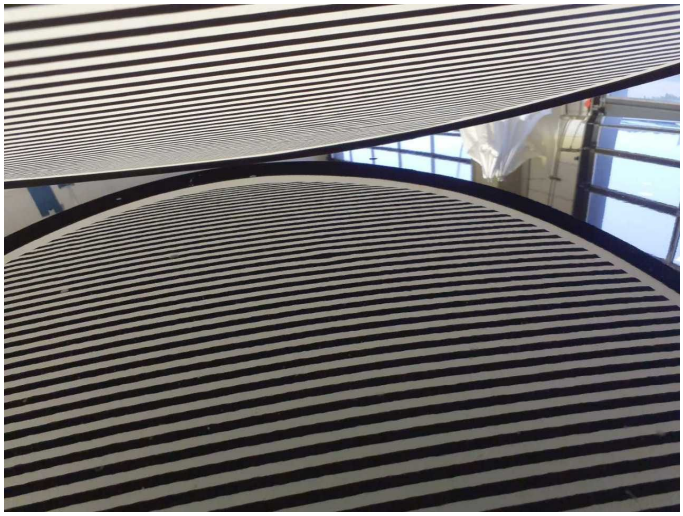
Damage 2: Roof: Roof - dent(s) - Smooth repair work

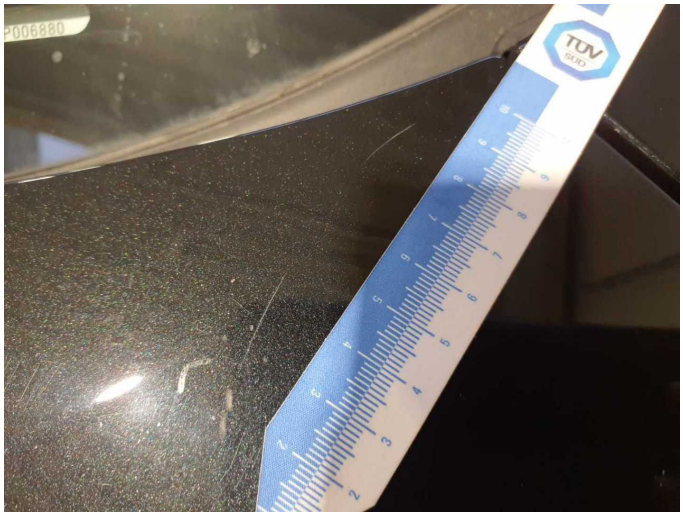
Damage 4: Bonnet: Bonnet - Scratch(es) - Paint

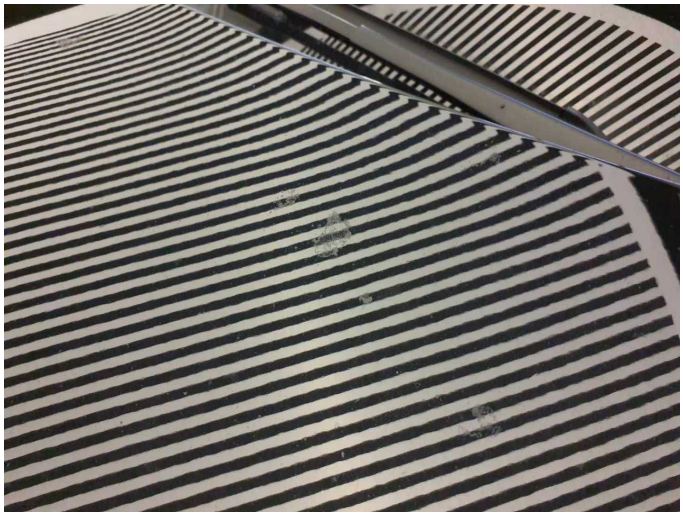
Damage 4: Bonnet: Bonnet - Scratch(es) - Paint

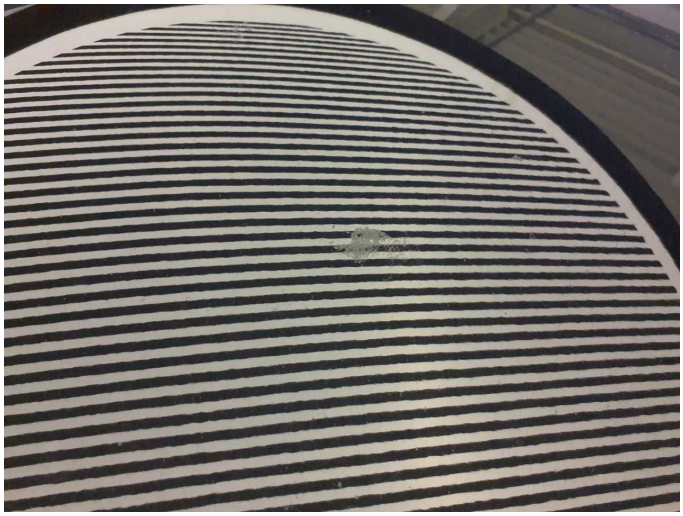
Damage 4: Bonnet: Bonnet - Scratch(es) - Paint

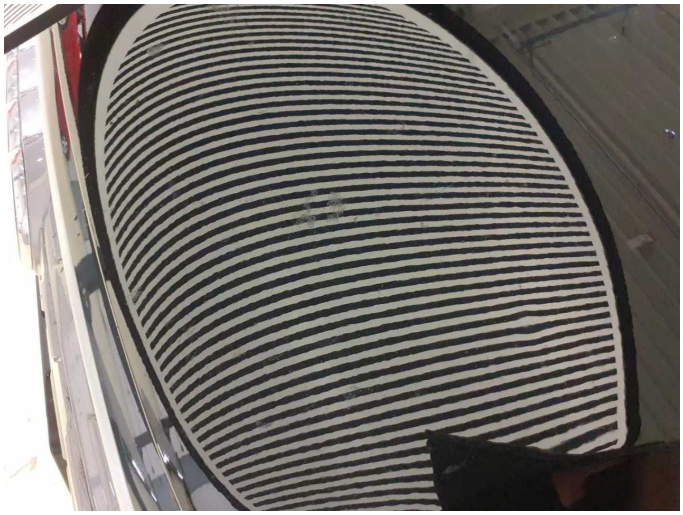
Damage 4: Bonnet: Bonnet - Scratch(es) - Paint
