TÜV SÜD Auto Partner GmbH
Wiesenring 2
04159 Leipzig

Expertise

Protocol number: 47980449
Order No. / Reference: 27041818
Inspection date: 7 Oct 2026

Manufacturer: Skoda	Model: Kodiaq 2.0 TDI 4x4 DSG Tour
VIN: TMBLJ7NS5P8054337

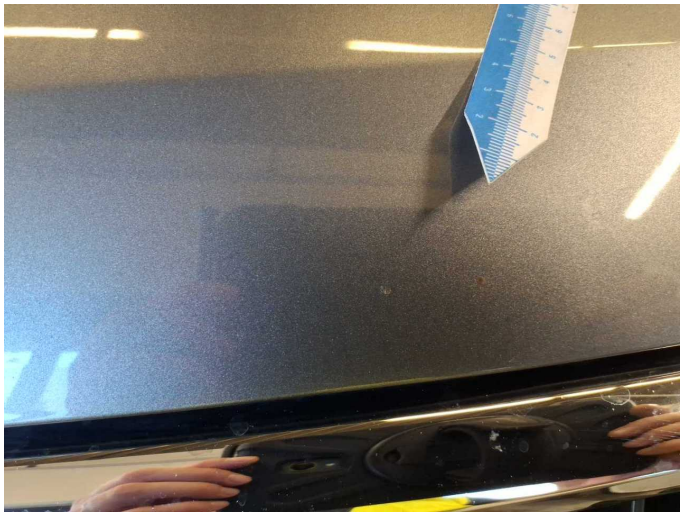
No.	Component group	Description
1	Bonnet	Bonnet - Stone chips - Paint

Damage 1: Bonnet: Bonnet - Stone chips - Paint

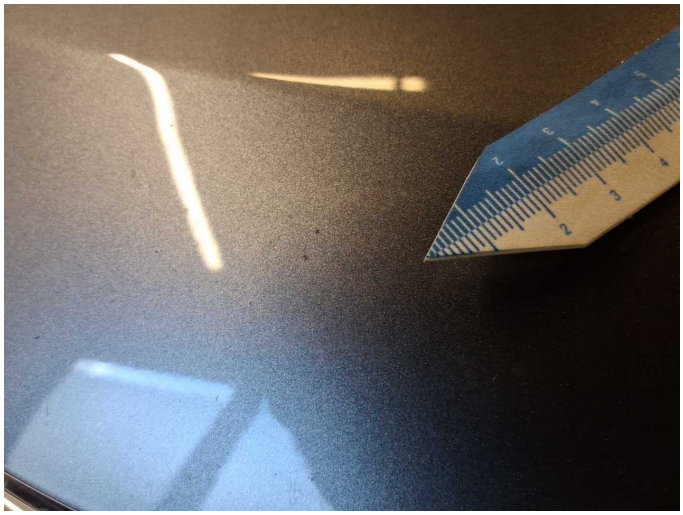
Damage 1: Bonnet: Bonnet - Stone chips - Paint
