Expertise

Protocol number: 47210797
Order No. / Reference: 26837648-1
Inspection date: 14 Aug 2026

Manufacturer: Opel	Model: Zafira Life 2.0 D M Edition
VIN: VXEVEEHTMMZ071507

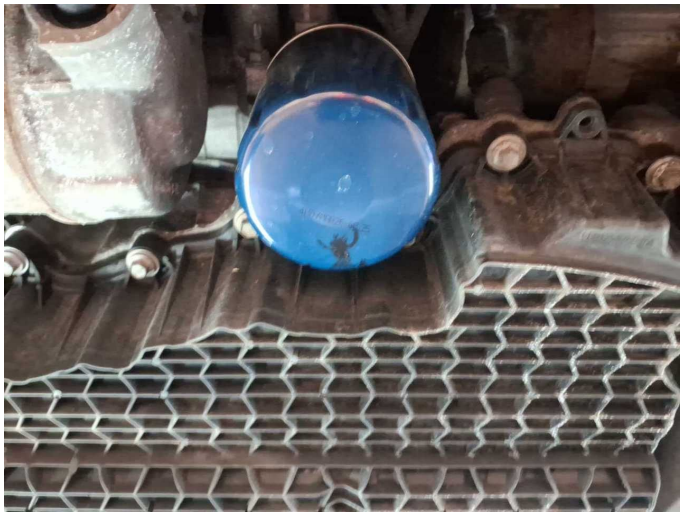
Damage 5: Engine: Engine (Motor / Getriebe) - Leaking - Perform diagnosis

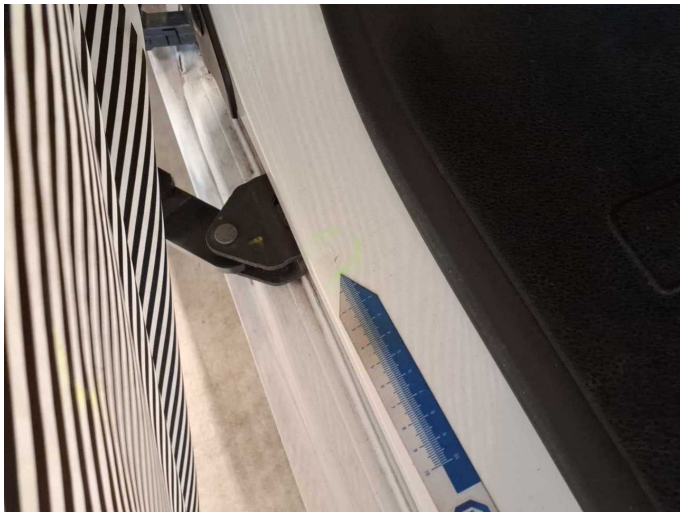
Damage 10: Side panel - rear right side: Sill - Dent / paintcoat damage - Smart repair

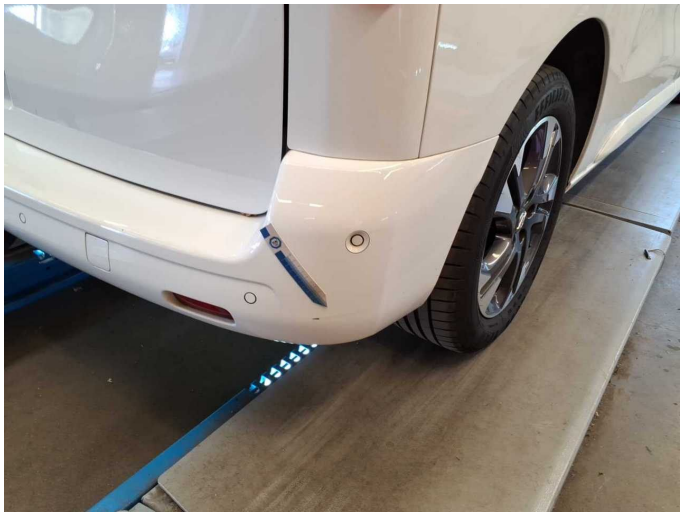
Damage 12: Rear bumper: Rear bumper - Scratch(es) - Paint

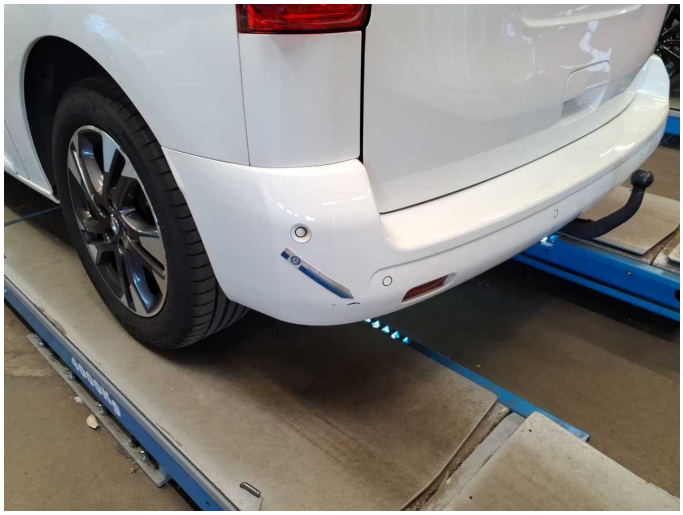
Damage 12: Rear bumper: Rear bumper - Scratch(es) - Paint

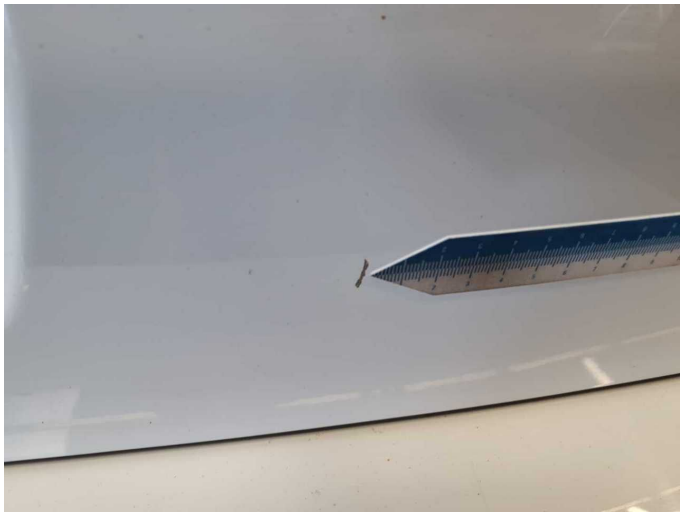
Wear and tear 3: Boot lid / rear door: Boot lid - Scratch(es) - No deduction

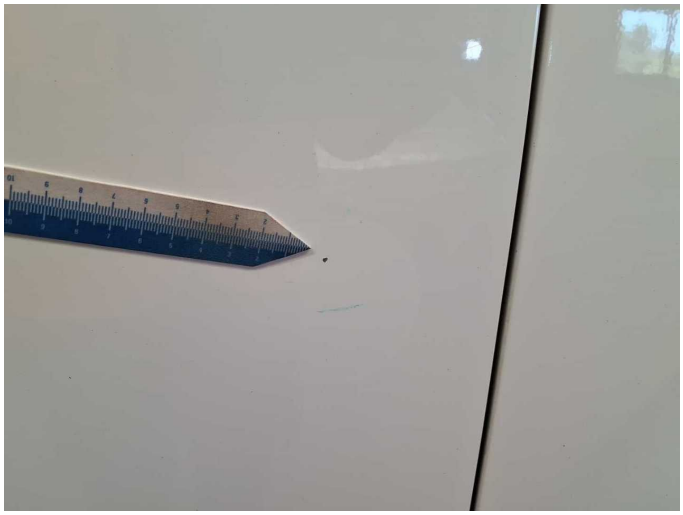
Wear and tear 4: Sliding door - left side: Sliding door with glass panel - Scratch(es) - No deduction
